11TH HARDWOOD CONFERENCE PROCEEDINGS

Sopron, Hungary, 30-31 May 2024

The impact of litter forest fires on the internal structure of wood from stem of beech trees

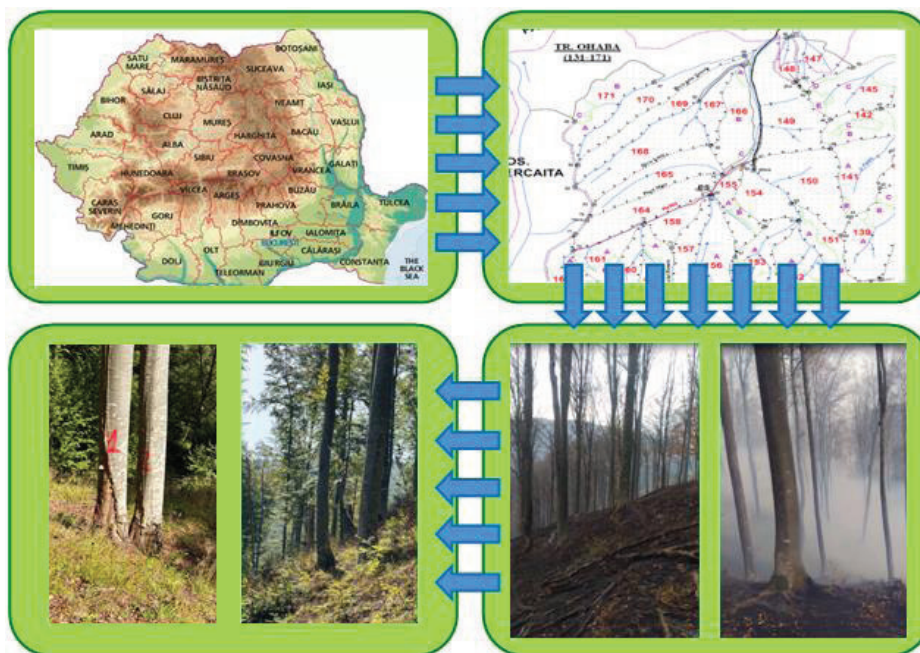
The fire that affected management unit 166 broke out in October 2019 in plot 165 and lasted 3 days. In extinguishing of the fire were participated foresters, firefighters, volunteers, and a helicopter. Practically, the fire started from boundaries number 78 to 80 (Figure 1), developing from the valley to the peaks, after which it descended again, affecting a total area of 15 ha in parcels 165 and 166, of which 10 ha only in the management unit number 166 (Figure 1).

Figure 1: Research location, images of the 2019 litter forest fire and the current state of the stand

extracted. This fact led to the extraction of the damaged trees so that at the time of making the determination, the remaining trees did not seem to be depreciated, growing in relatively good conditions (Figure 1). Trees under study were visually analyzed and found to have either dry or cracked bark at the base, or the bark had fallen from the trunk which, in the respective regions, had dead wood (Figure 1). After choosing the trees, the north direction was marked on each of them, and three levels (at 30, 60, and 90 cm above the ground) were measured and marked to carry out the investigations. The determinations were initially made with the Arbotom Rinntech sound tomograph, after which, depending on the reconstructed tomogram, were chosen the directions and positions to carry out additional investigations with the IML Resi F-500 resistograph. The principle of operation and application of the method of assessing the quality of wood with sounds was described in the works of Musat 2017, Musat et al. 2020, and Musat 2023. It should be noted that 7 hammer blows were applied to each emitting sensor, the number of blows being chosen under the ambient noise in the area and taking into account the recommendations in the specialized literature (Rinn 2014, Tarasiuk et al. 2007).

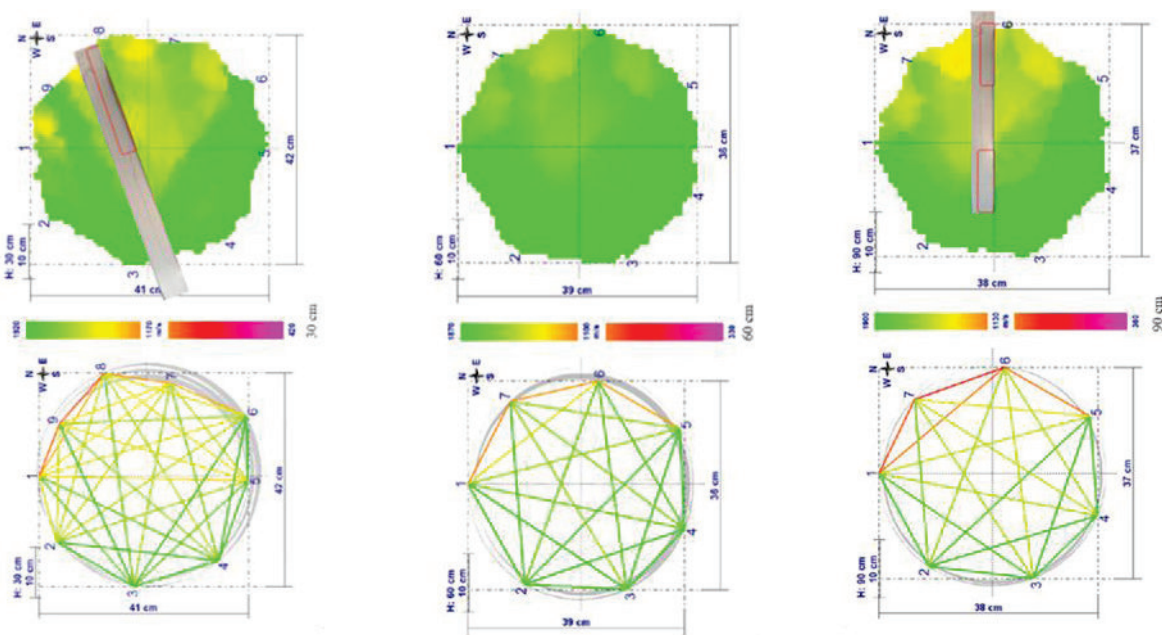
During the visual analysis of the first tree for which the results are presented, defects such as cracked bark on the trunk, dead wood, and the beginning of decay, visible from the outside, were identified at the base of the trunk, in the northwest-west-east-southeast direction. There is also a fruiting body at the height of 90 cm, in the west direction, very close to the sensor S_6 located at this level. From the analysis of the tomograms (Figure 2), it can be seen that inside the trunk, but also from the periphery to its center, a series of internal irregularities appear, which make the sound transfer speeds through the wood lower, and the tomograms to be colored in shades of yellow and yellow-green. All these irregularities appear in the direction of fire advance, i.e. north – east – southeast.

Figure 2: The field investigations carried out for a beech tree: the links between the sensors; the scale of values specific to the determination, the reconstructed tomogram and the resistogram

Compared to the expansion of this area from the level analyzed to the next level, it is found that the internal irregularities, which may indicate a possible degradation of the wood, occupy approximately two-thirds of the section at the level of 30 cm, after which the affected surface narrows to the level of 60 cm. At 90 cm, although it no longer occupies an area as large as at the 30 cm level, the tomogram shows important signs of degradation and internal irregularities of the wood, which lead to the appearance of orange shades in the area of the neighboring sensors S_{6-7} . This can be attributed to the action of xylophagous fungi, present even through the fruiting bodies, which led to the degradation of the wood (Musat, 2017).

To be able to draw pertinent conclusions regarding the state of the wood inside the trunk, additional, punctual investigations were carried out, both at the level of 30 cm from the ground, a situation in which the resistogram was made in the direction of the sensor S_8 , and at the level of 90 cm, on the direction of the sensor S_6 (Figure 2). Analyzing the resistograms, it is found that the first third of the length of both resistograms shows structurally destroyed wood, in the sense that the relative resistances to drilling are either zero (S_6 – at 90 cm) or very reduced. It is also observed that after the areas with degraded or even rotten wood, the resistances begin to increase, but no significant variations appear which denotes some structural change inside the trunk, which leads to non-differentiations between latewood and earlywood in the annual rings (Musat 2017, Musat 2023).

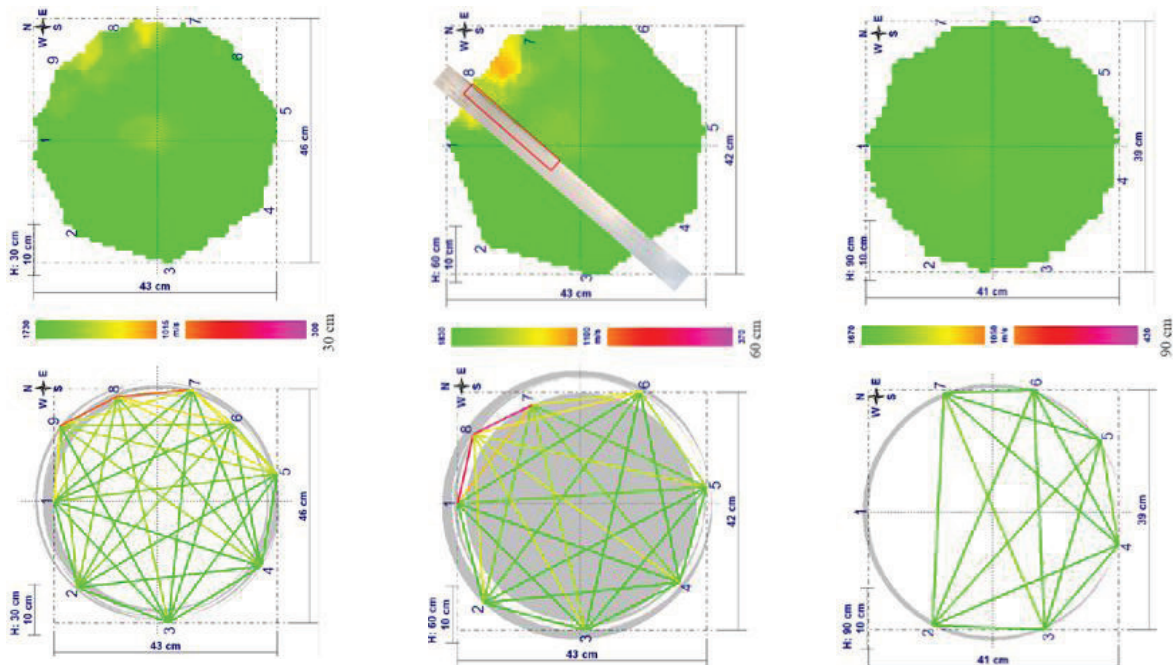
Another beech tree shows, in the north, northeast, and east area, up to the height of 1.20 m, dry and cracked bark on the trunk. In addition, an area of dead wood appears at the base, with strong signs of decay, up to a height of 40 cm. Analyzing the results indicated by the tomograph in the case of the 30 cm section (Figure 3), it is observed that there are lower sound transfer speeds through the wood, marked in red on the image with the connecting lines between the sensors, which are highlighted on the tomogram (Figure 3) with yellow-green shades between sensors S_{7-8-9} .

Figure 3: The field investigations carried out for another beech tree: the links between the sensors; the scale of values specific to the determination, the reconstructed tomogram, and the resistogram

At the 60 cm level, it is observed that the wood degradation is concentrated between the sensors S_{7-8-9} (Figure 3), an aspect indicated on the tomogram by shades of orange. This is also the reason why a resistogram was made in the direction of the sensor S_8 , at the level of 60 cm (Figure 3). From its analysis, it can be easily seen that the entire section shows wood with low resistance to drilling. In addition, on the first third of the length of the resistogram, extremely low resistances appear, close to zero, which indicates wood with a destroyed structure. By comparing the position of the sensor S_8 on the trunk and the condition of the wood as it appears in visual analysis, it is found that the resistogram was taken just above the decayed area at the base of the trunk, which clearly shows that the rot has progressed upwards on the trunk. At the 90 cm level, both the tomogram (Figure 3) and the image with the connecting lines between the sensors indicate wood where the sound transfer speeds are high, which makes that these images to be colored in green.

Comparing the images from the three analyzed levels with the real condition of the wood, visible from the outside of the trunk, and with the resistogram made in the direction of the sensor S_8 at the 60 cm level (Figure 3), it is quite clear that the structure of the wood in the northwest area – north–north–east

is almost destroyed. The poor quality of the wood inside the trunk cannot be identified on the tomogram in the real stage, which can be attributed to the denser or less dense medium through which the sounds are transferred (Musat 2017). In this sense, the speed of sounds differs, first of all, concerning the density of the wood (Beldeanu 2008, Rinn 2014), but it can also be influenced by its humidity (Beldeanu 2008). Thus, the presence of rot in the area and the fact that the wood is in various stages of decay can lead to an increase in wood moisture as a result of the activity of xylophagous fungi (Ciubotaru 1998, Beldeanu 2008).
