Catastrophic landslide stabilization on a restricted area through a combined solution in Bran, Brasov County

M Măntulescu¹ and I Tuns^{1*}

¹ Transilvania University of Brasov, Faculty of Civil Engineering, Brasov, Romania

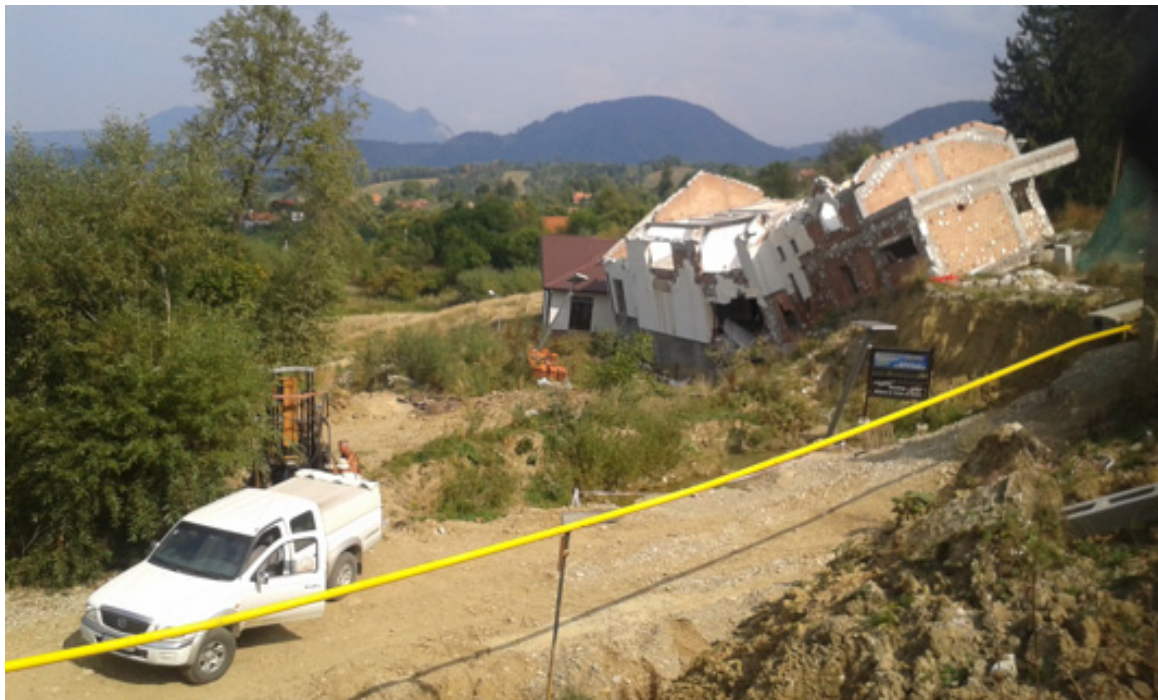
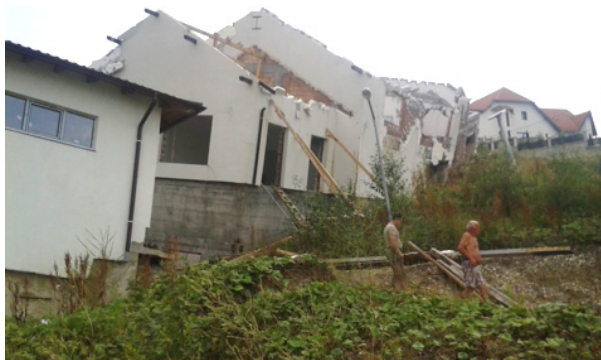
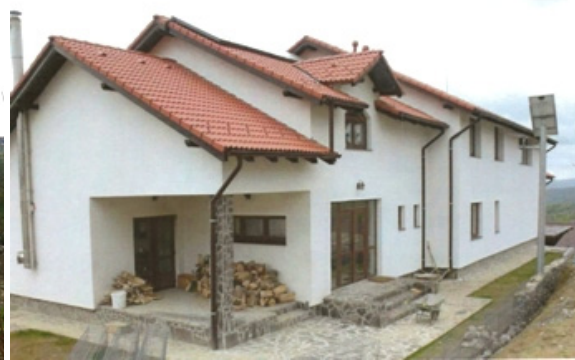
Landslides has affected the street Bradul Inalt from Sohodol district on the length of 50 meters, with moving a compartment (the northern one) by about 6 meters horizontally and 3-4 meters vertically (figure 1).

Figure 1. (a) Local effect of the landslide; (b) A building destroyed by the landslide; (c) The same building before the landslide.

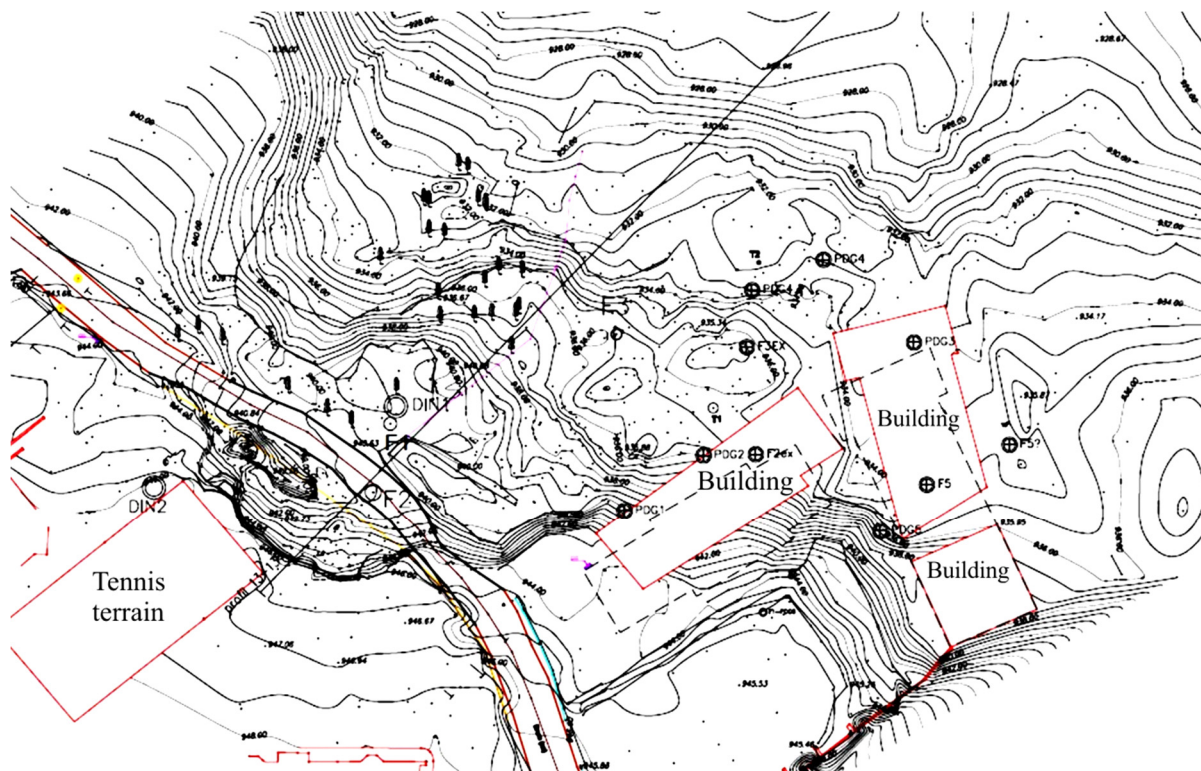
The slip has affected the communal road on a length of about 50 meters owned by the Bran City Hall, as well as two buildings, privately owned, downstream. In fact, the sliding is much broader, having a length of over 500 meters, over a width of 50-100 meters in the north-north-eastern direction of the road to the affected area (figure 2).

Figure 2. Detail of the landslide plan (contours are at every 0.5 m).

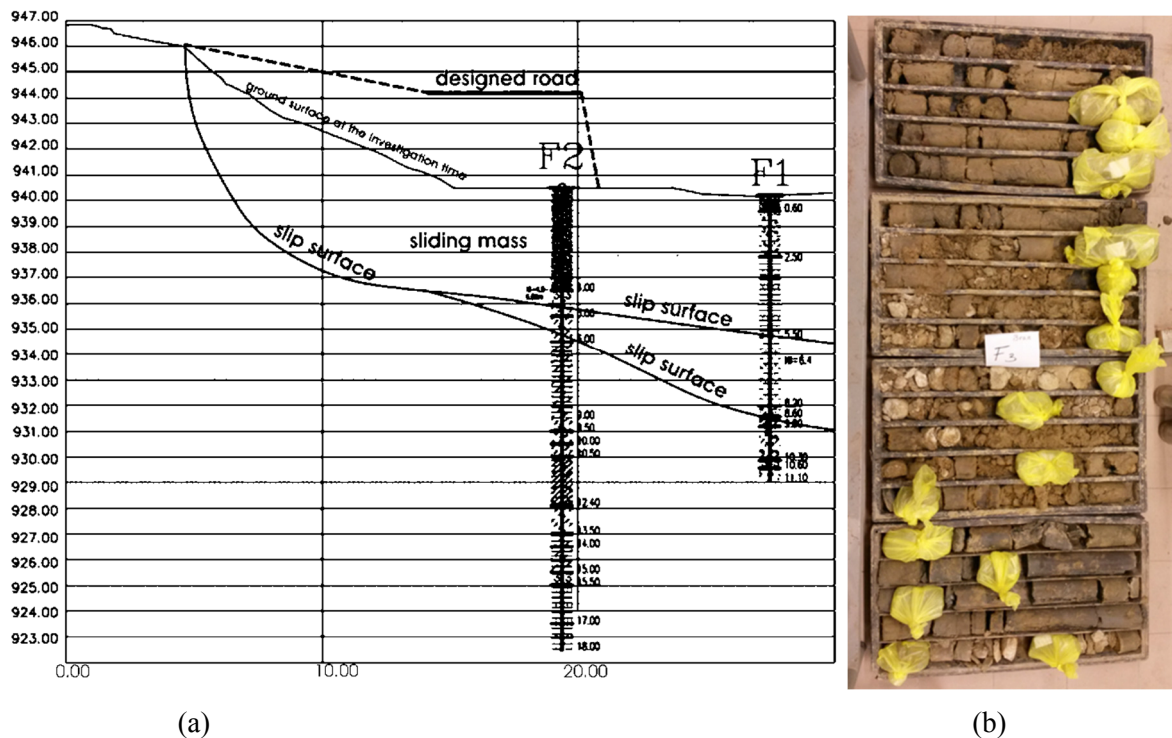
According to the groundwater level also, the slip surfaces are situated at 6 m, and 9 m depth from the ground level at that time (figure 3 a).

The results of the investigations revealed a complex lithology, in which cohesive soil alternates with non-cohesive material (figure 3 b).

Figure 3. (a) Simplified landslide profile; (b) Samples from borehole F3.

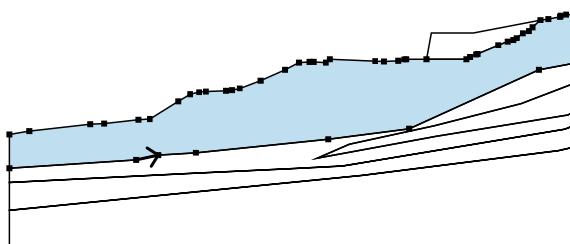
Figure 4. Meshing profile with highlighted sliding mass (with GEO5).

Slope stability (figure 4) was determined with Geo 5 software by analytical methods. Presuming only that the road will be restored, the safety factor was unacceptable (less than one).

On the next step it was calculated adding a double sheet of piles; the piles dimensions were adjusted until it has been obtained a safety factor over 1.5.

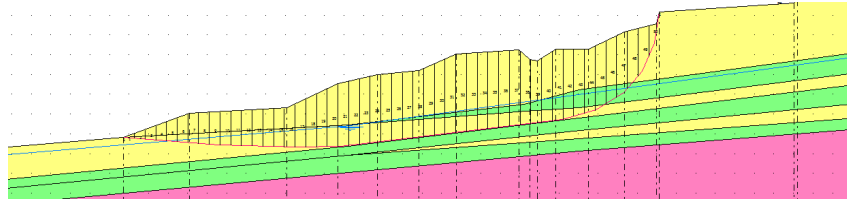
General stability analysis (figure 5) assuming that the slip surface has a multi-planar shape. The analysis (made with Geo 5 and Geo-Slope software) on the existing situation calculated a safety factor equal to $F_s^{\text{static}} = 1.02$.

Figure 5. Analysis on the existing situation.

So the condition of verification, even in analytical way, under static conditions is not satisfactory and it is required to ensure the overall stability of the slope. After re-profiling the slope to correct the existing road, the safety factor decreases. It is necessary to carry out retaining works down the road at the limit of the existing platform in order not to require additional expropriations. Thus, a retaining work was provided from pilots drilled down the road on two rows of pilots to reach the safety factor $F_s = \min. 1.3$ (figure 6). The re-profiling of the downhill slope will be made with a slope of 1:6 and upstream of the road will be re-profiled with a slope of 1:3. In this case the safety factor will increase up to $F_s^{\text{static}} = 1.39$.

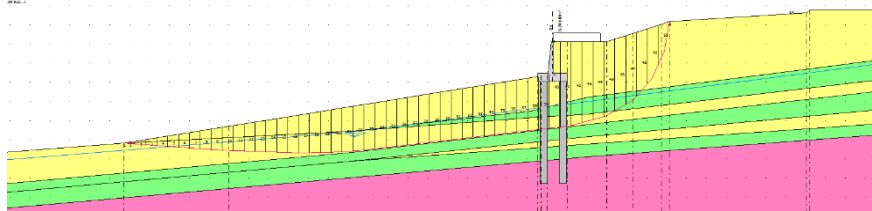
Figure 6. Analysis on the existing situation with a retaining structure.

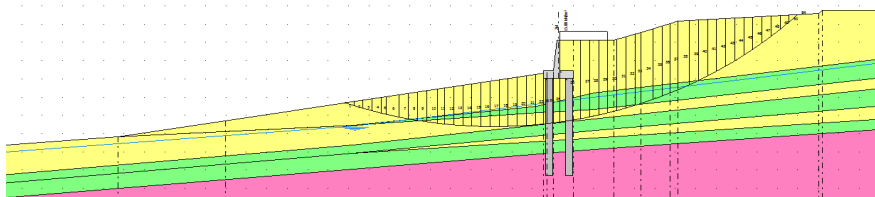
Analyzing the general stability of the versant in seismic conditions according to SR EN 1998-125/2004 for approach 1, group 2, were applied the following partial coefficients: $\gamma_\phi = 1.25$ (partial coefficient for the internal friction angle of the material) and $\gamma_c = 1.25$ (partial coefficient of the cohesion of the material); as a result the safety factor was $f_{s_{\text{seism}}} = 0.72$, much less than the acceptable $F_s^{\text{adm}} > 1.0$. General stability analysis by cylindrical - circular slip surfaces (figure 7 and figure 8) has led us to lower values of the safety factor $F_s^{\text{seism}} = 0.66 < F_s^{\text{adm}} = 1.0$.

Figure 7. General stability analysis by cylindrical - circular slip surfaces.

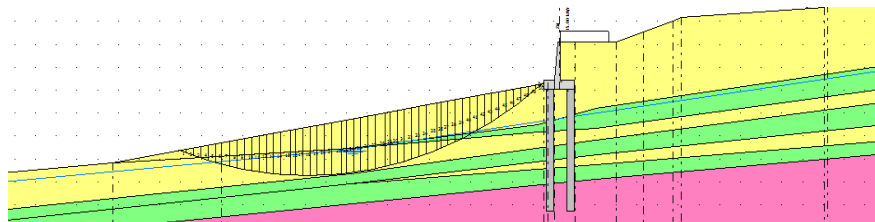
Figure 8. Analysis of downstream stability of support after re-profiling assuming a cylindrical - circular slip surface.

The slope is not stable downstream of the retaining structure. To ensure the stability of the slope upstream of the supporting work it must be able to take the thrust of $E = 1150 \text{ KN}$. The main solution was to increase the pile's dimensions.

In these reasons, to accommodate additional loads that were induced to execution by downstream compaction, there were provided two rows of piles embedded in the base rock layer with an average length of 18.00 meters in the chess board with 1.50 m diameter, at a distance of at least 3.50 cm apart and 2.0 m between strings (figure 9).

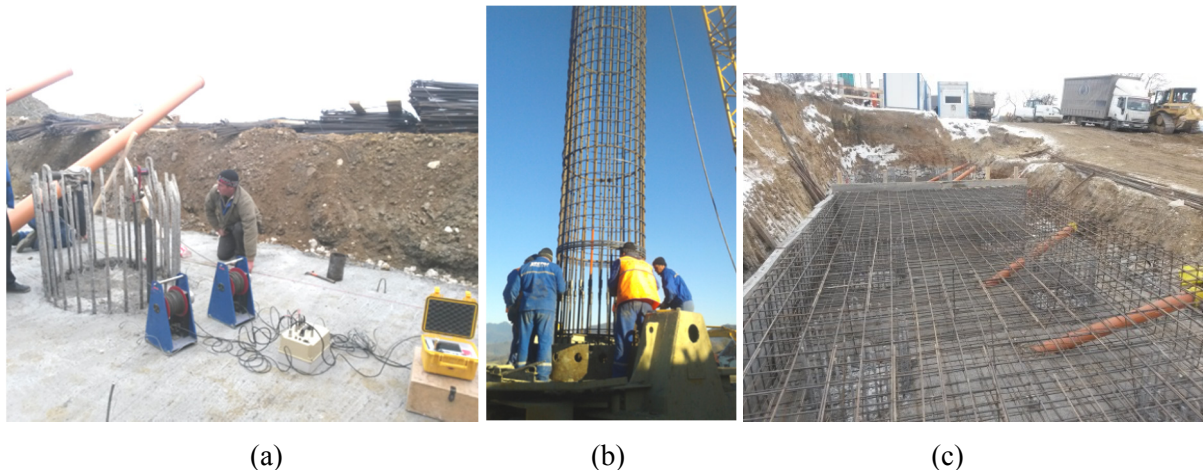
Figure 9. Aspects during and after the executions: (a) checking of pile's continuity with down-hole method; (b) introducing steel reinforcement cage of the piles (c) beam's reinforcement with anchors casing; (d) panoramic view of finished structure; (e) rehabilitated road segment.

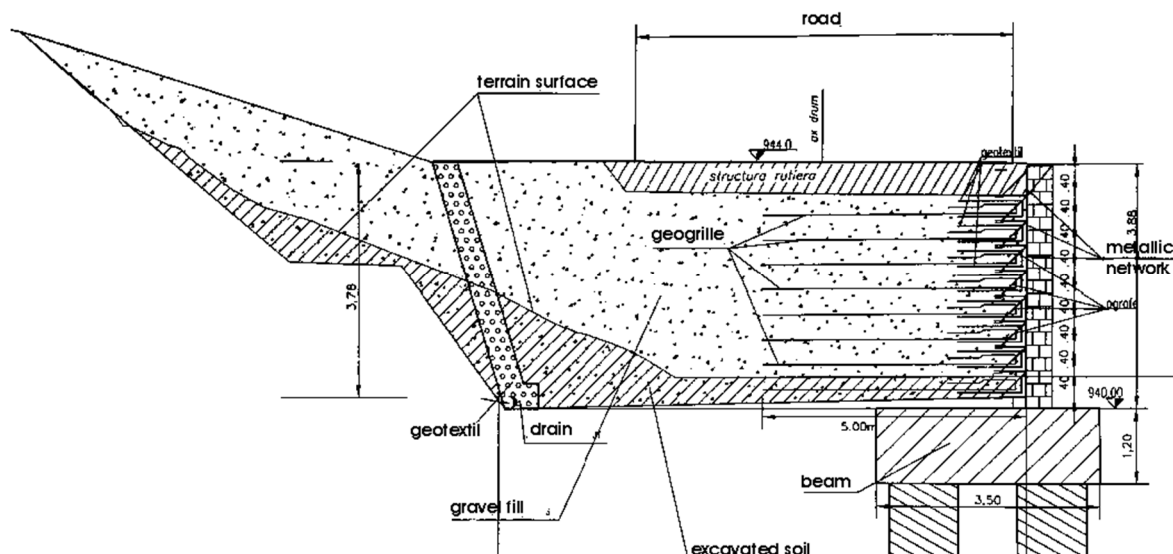
Figure 10. Typical profile through stabilization's structure.

The so described position of the piles is also in agreement with the [2] report's conclusions. The reinforced soil was calculated according to [3]. The geogrid is 4 meters large, enough to act like a support structure (figure 10).
