DAMAGE ANALYSIS AND RESTORING OF STRUCTURAL INTEGRITY OF PELTON RUNNER AFTER REPAIR WELDING: CASE STUDY

Originalni naučni rad / Original scientific paper

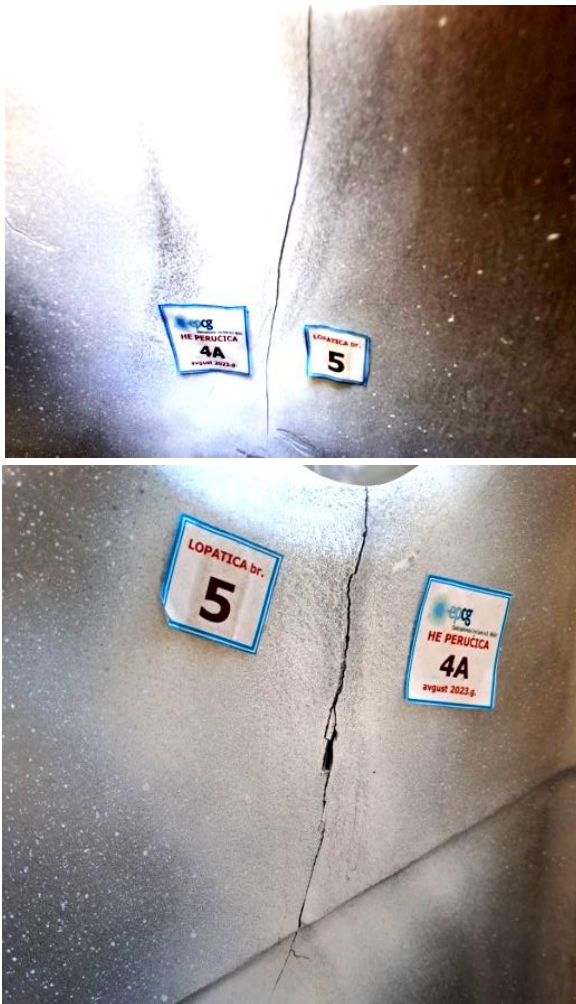
During regular annual maintenance of Pelton turbines, a large crack was detected in blade no.5, using NDT methods, namely magnetic particles. Figure 3 shows the appearance of the detected crack of length 200 mm, from both front and back sides. It was confirmed that this crack was caused by cavitation, leading to the decreasing of the blade's thickness and crack initiation, where even at lower load level the rapid crack growth can occur. It must be noted that this case represents a considerable crack growth during a single year.

Figure 3. Detected crack on Pelton runner's blade, 200 mm length: front side (top); back side (bottom).

All of the above imposed the question of what should be done about this damaged runner. Taking into account its sophisticated features, this part with such damage should not be allowed to operate, where its failure could cause downtime and severe financial losses. Since it was impossible to determine with certainty whether this was a defect that occurred during design, and there was no evidence of casting defects (taking into account how Pelton runner was made) that could cause crack initiation (confirmed by NDT), it was concluded that the best course of action would be to repair weld the turbine blade using an electrode of higher toughness compared to the base material. One of the main reasons for this electrode's type selection is better absorption of impact forces. In this way, future damage of this zone could be prevented. For this purpose, the austenitic electrode was the choice for the filler material.

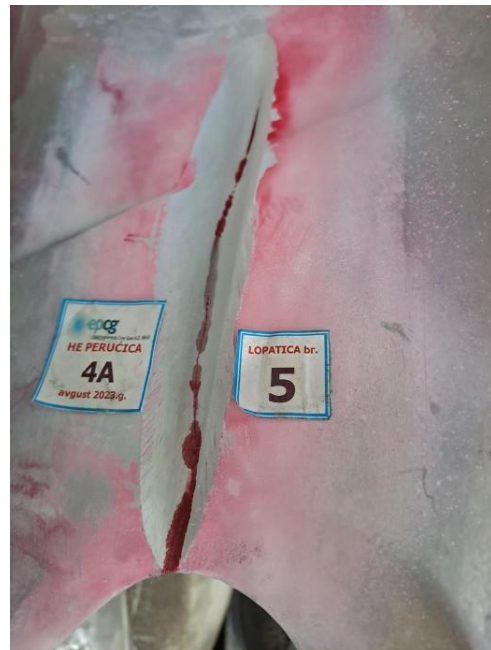
Figure 4. Groove on Pelton runner blade, on the back side.

Prior to repair welding, it was necessary to machine the U groove by grinding of the crack on the blade back side, up to approximately one half of its thickness, in the direction

of the crack, Fig. 4. The so-called 'removal' of the crack was then performed, and penetrant testing was also done in order to examine the state of the damaged area of the blade.

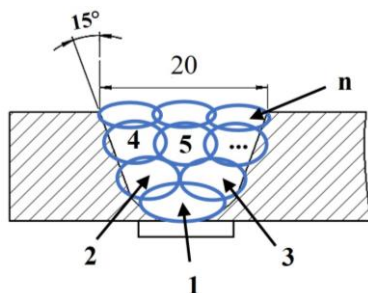
Figure 5. Filling plan for U groove of runner's blade.

Immediately before welding, the electrodes were dried at 300 °C for 2 hours. Due to small blade thickness, there was no need for preheating. Welding parameters are given in Table 5, whereas the welding plan is shown in Fig. 6. Interpass temperature was not greater than 200 °C. The required level of welded joint quality was B (according to EN ISO 5817 standards).

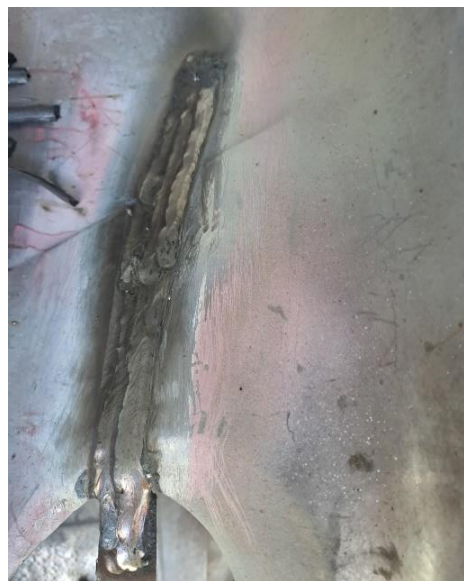
Figure 6. Blade groove after filling on the back side.

After filling the groove, a 3 mm surface layer was welded above the cap weld. This was done for two reasons: (i) to avoid undercuts after grinding, and (ii) to anneal the cap pass. The appearance of the groove after repair welding is shown in Fig. 6. This was followed by making a small U groove on the blade front side, while also monitoring the damage of the surface. Welding on the front side of blade no.5 was performed in the same way as the back side. After cooling of the welded joint to ambient temperature, the start plate was removed, and the blade was ground and polished to its design geometry, from both sides. Grinding was performed to minimum surface quality of $R_a = 1.6 \mu\text{m}$. The front and back sides of the repaired blade are shown in Fig. 7.

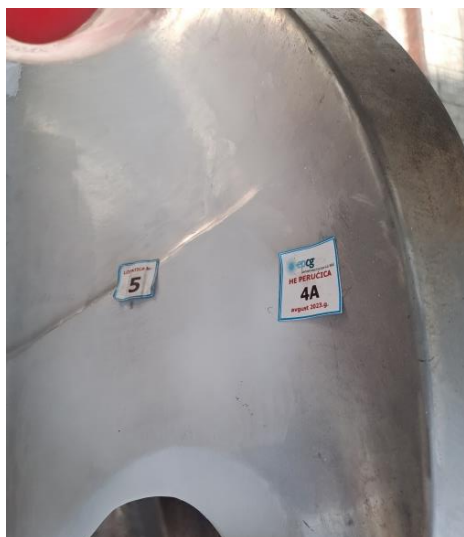
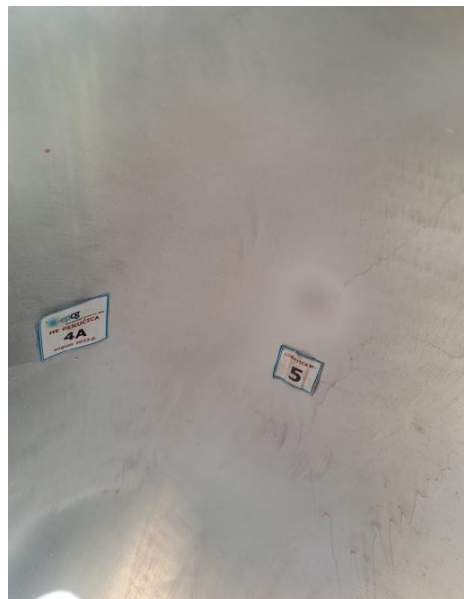
Figure 7. Repaired section of blade no. 5 where the crack was located: back side (top), front side (bottom).

After grinding and machining of the blade geometry to its predefined dimensions, NDT was performed using visual and penetrant methods, with a scope of 100 %. These tests did not reveal crack-like defects, pores, undercuts nor any other indications, which confirmed that the Pelton turbine in question fulfils the requirements for further exploitation.
