# Novel Method for Failure Modes Detection in UV-Cured Clear Coated Polymer for Automotive Interior Mechatronic Devices

Ion Cristian Braga, Razvan Udriou and Anisor Nedelcu

<https://doi.org/10.3390/polym14183811>

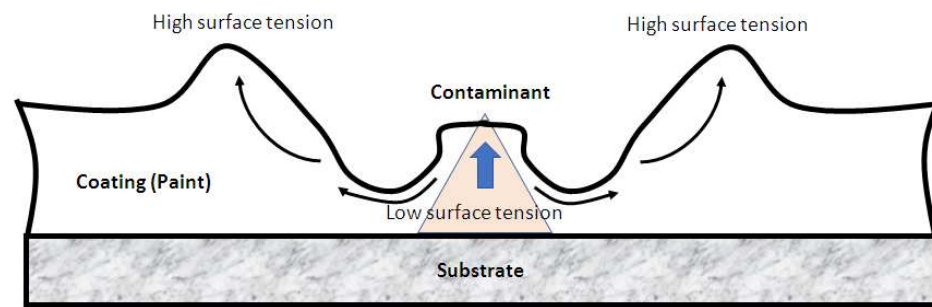
Based on the proposed methodology, one very rarely occurring failure mode was detected as very important and at a high level of scrap, the so-called fish-eyes defect. This defect is caused by a contaminant with low surface energy, from which the applied coating is displaced, as shown in Figure 3 [30,31].

**Figure 3.** Contamination defect called as fish-eye defect.

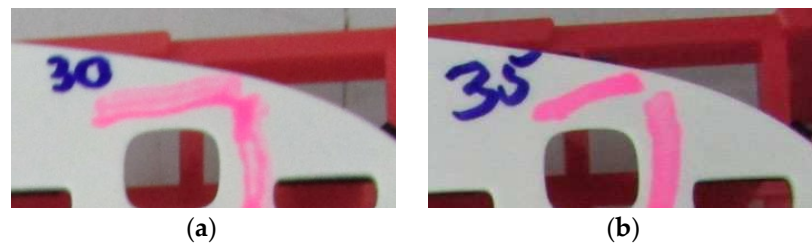
The surface of the parts resulted from the injection molding process were analyzed by Dyne Pens, and the results about the surface tension test are shown in Figure 4. The affected areas of the parts are determined for a 30 mN/m surface tension related with the

coated parts which present the fish-eye defect. The parts coated without the fish-eye defect have been the one measured at 35 mN/m surface tension.

**Figure 4.** Surface tension value is (a) 30 mN/m for bad parts; (b) 35 mN/m for good parts.

To improve the adhesion of the surface by using corona discharge or low-pressure plasma treatments [32] cannot be an affordable industrial solution in case of injected plastic parts due to expensive processes designed to handle the parts between process steps. A possible solution to increase the adhesion by surface preparation could be the cleaning with a solvent [33] or even cleaning with dry ice CO<sub>2</sub> blasting [34].

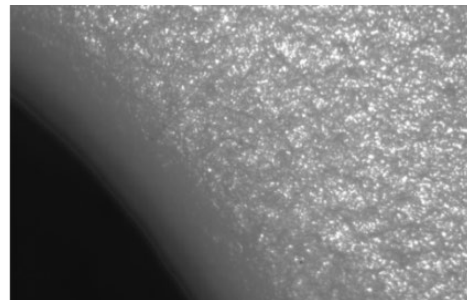
There were no defects detected from the visual and microscopic analyses (Figure 5).

**Figure 5.** Microscopic analysis of injected parts.

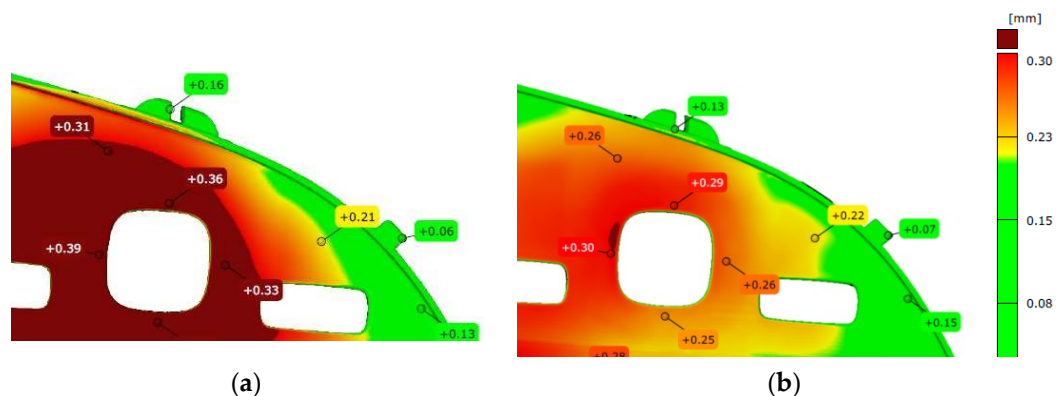
The parts produced in the eight different cavities of the mold were optical 3D measured to investigate their 3D shape. This factor was taken into analysis, supposing that the surface energy will be influenced by the 3D shape. A sample of three parts has been measured by optical ATOS Scan Box machine. The measurement results show that the parts out from the cavities 3, 4, 5, and 6, from the eight cavities of the mold, were detected with bigger deformations compared with the ones from the cavities 1, 2, 7, and 8 (Figure 6). These results do not lead to a clear link with the possible failure mode of fish-eye defects occurrence.

**Figure 6.** The results of optical measurements of: (a) a part out from the cavities 3, 4, 5, and 6; (b) a part out from the cavities the cavities 1, 2, 7, and 8.

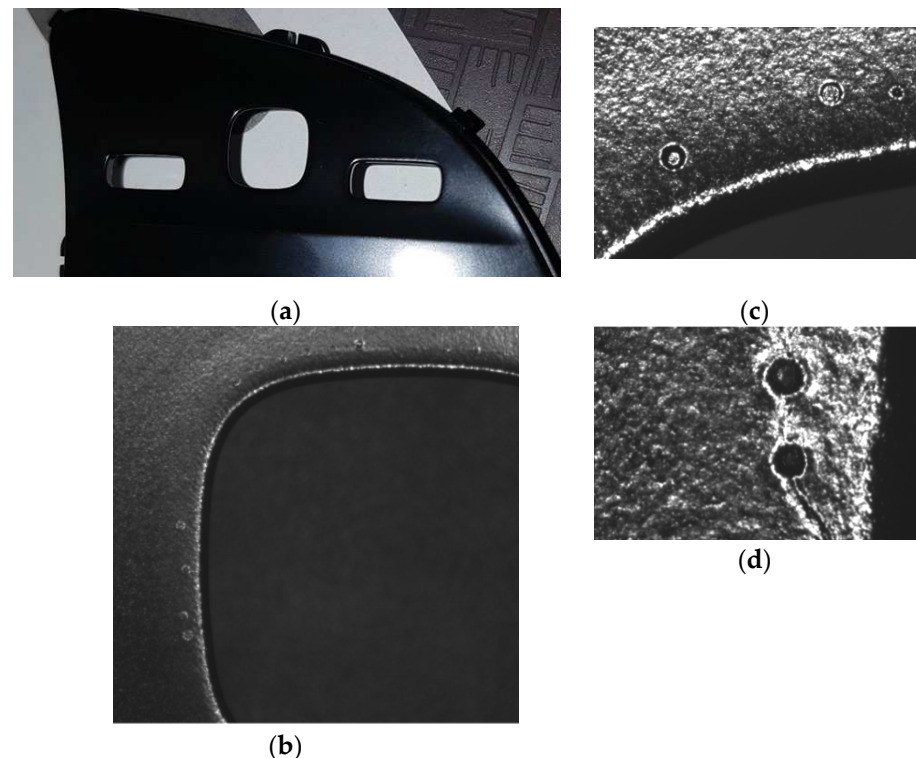
The optical microscopy investigations of the coated parts, used to understand the mechanism of the failure, have shown the occurrence of the defects on the plastic parts first layer coating, on the nearest area of the rectangle windows from the parts. Investigation led to fish-eye defect on the primer painted parts (Figure 7b–d).

**Figure 7.** Coated parts analysis: (a) Visual test; (b) Optical microscopy analysis of the rectangle window of the part; (c) Optical microscopy analysis on the upper zone of the rectangle window; (d) Optical microscopy analysis on the right zone of the rectangle window.

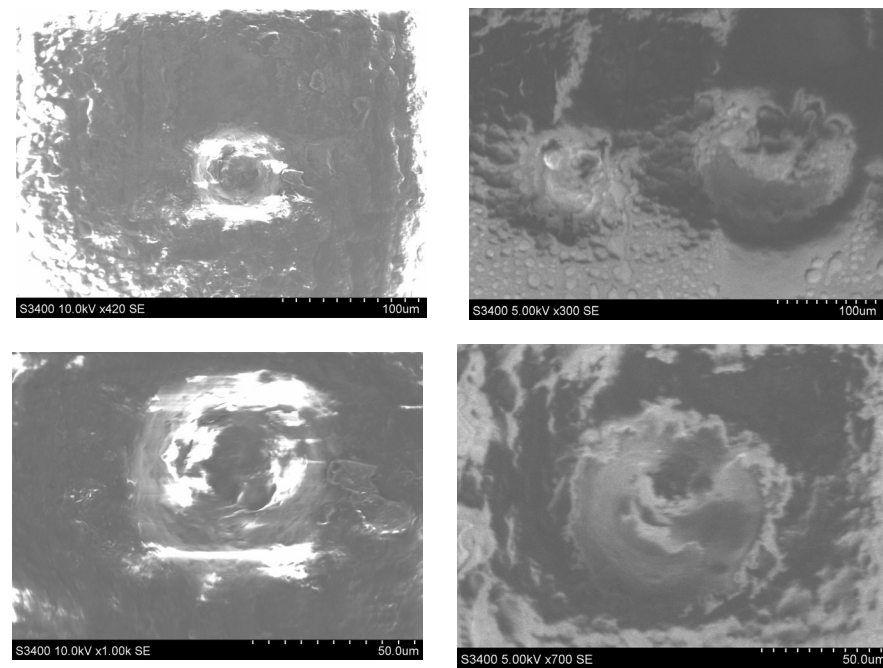
A SEM microscopy analysis study was performed in different four areas to deeply analyze the fish-eye defects on the nearest area of the rectangle windows of the part, as is shown in Figure 8. This defect is characterized by circular voids or crater-like openings. The size of the circular shape defect was in the interval 50 to 178 microns.

Figure 8. SEM microscopy analysis study in different four areas of the part.

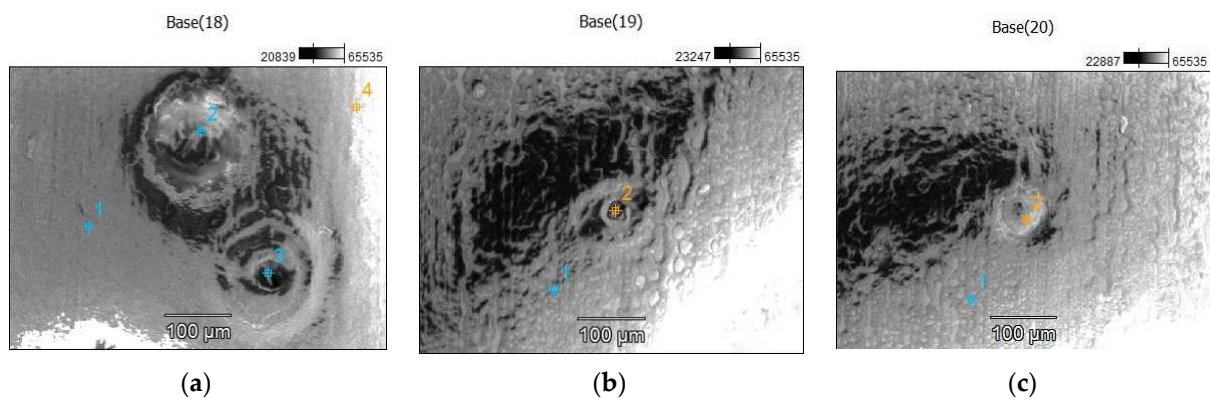
A number of three EDX analyses were performed within different areas which contain defects of the part, as shown in Figure 9. Four points were chosen for the first EDX analysis on the SEM image (Figure 9). Based on the results shown in Figure 10, only two EDX points are relevant (Point 1 and 2) for the following analysis. The results of the EDX analysis for the first area are presented in the Table 3. Similar EDX results, within only two points, were obtained for the other two interested areas from Figure 9. A possible contamination with a material such as oil or demolding spray during the injection process of the plastic part was checked by EDX analysis, and the results are shown in Figure 10.

Figure 9. Choosing the analyzed EDX points (1, 2, 3 or 4) in three different zone with defects of the part: (a) EDX points in Base(18) area; (b) EDX points in Base(19) area; (c) EDX points in Base(20) area.

The EDX analysis did not reveal any clear element that should not be present, because in the plastic substrate mainly hydrocarbons are present [16], and the base layer is also a hydrocarbon, so that the presumption of oil or release agent contamination was maintained.

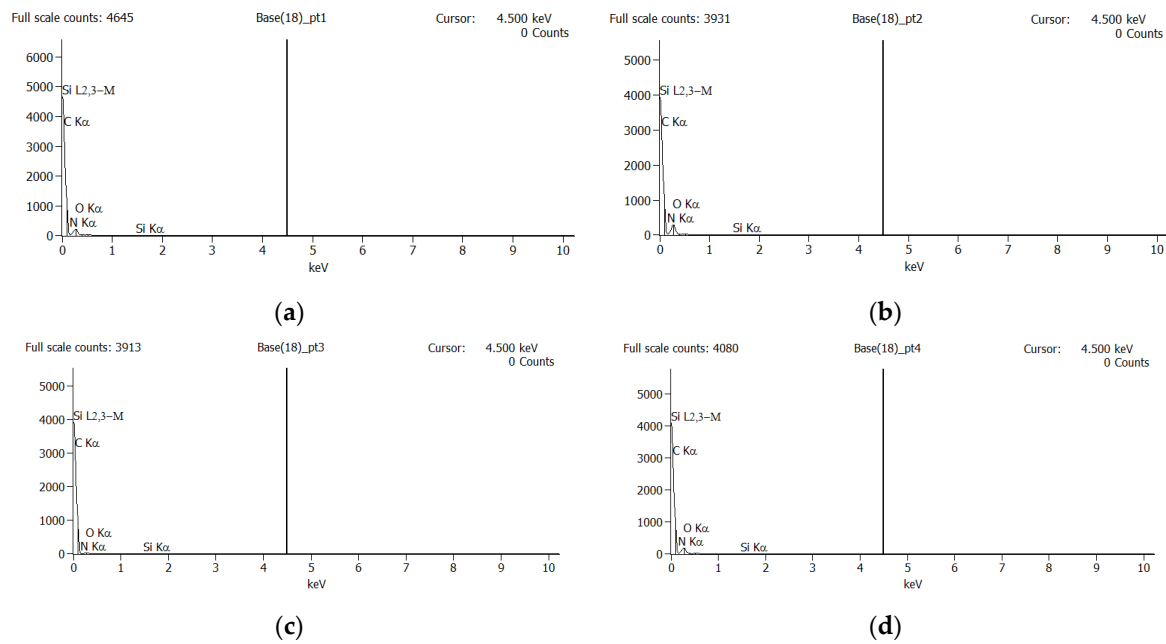
**Figure 10.** EDX analysis for the four points within the case (a) from Figure 9: (a) Point 1; (b) Point 2; (c) Point 3; (d) Point 4.

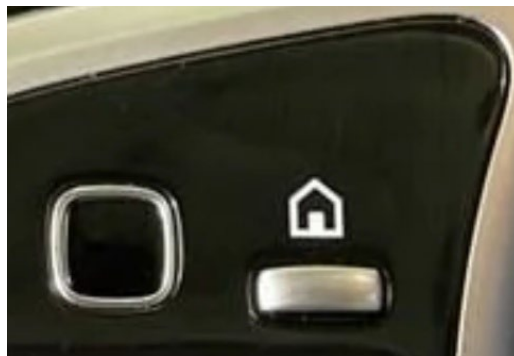
Laser-engraved parts after the black primer coating process are visually inspected to check that the paint has been completely removed. Microscopic analysis and measurements are performed to inspect the symbol line sizes as well as possible laser-etched edge defects (Figure 11). There were no defects detected from visual and the microscopic analysis, the process being optimized [36].

**Figure 11.** Laser engraving of the parts.

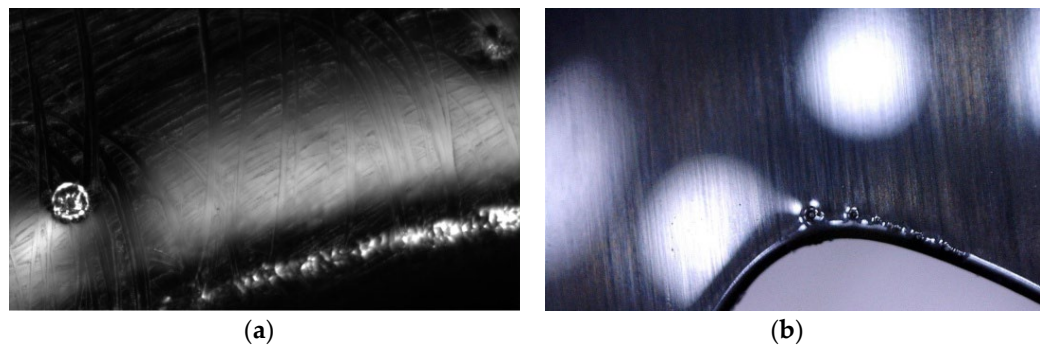
The thickness of the UV-cured clear coating has been measured, similar to the coating with primer. The result shows that they are not related to the “fish-eye” defects that appeared on the plastic pieces, as in the case of the primer, the thickness is in the specified tolerance with an average of 27 microns [5]. The “fish-eye” defects were detected on the UV-cured clear coating parts by the optical microscope, both in the area of square windows, but also at a distance from their edge (Figure 12a,b).

**Figure 12.** The issue (fish-eye) detected on the final clear coated parts: (a) in the area of the square windows; (b) at a distance from their edge.

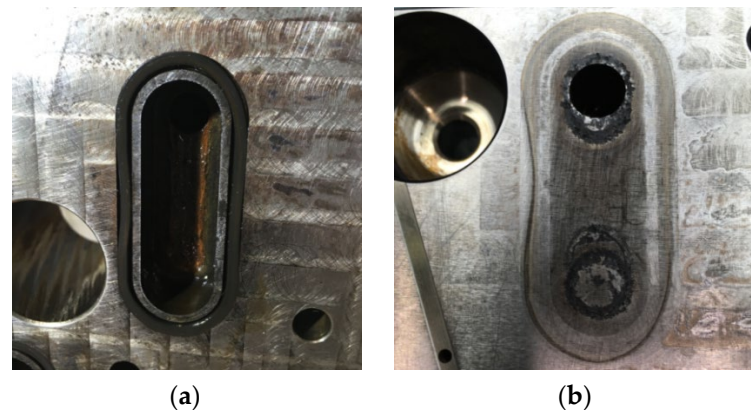
After re-analysis of both sides of the mold, checking the cooling system, some traces were detected in connection with a sealing “O” ring (Figure 14); the traces indicate that the escaped oil was drained at the location of the rectangular window and, due to the high temperature, was burned during the injection cycle and could not be detected as a clear contamination on the entire surface of the plastic part, not even by checking the surface tension.

**Figure 14.** (a) Injection molding tool with the O-ring affected; (b) Traces generated by bad assembly of O-ring.

Finally, the root cause leading to this fish-eye defect was the oil contamination during the plastic injection cycle in the area near the rectangular window. Thus, the hydrocarbons penetrated into the structure of the amorphous material of the part. During the painting with UV-cured clear varnish, the hydrocarbons had the role of the contaminant factor with low surface energy that caused the occurrence of the defect. The hydrocarbons have evaporated during painting with UV-cured clear varnish, and the small bubbles have been blocked by the drying process of the material during polymerization. Therefore, increasing the mold temperature as a factor in DoE shows the influence in the evaluated parts. The third factor, the laser etching current, was also related to the local temperature increase during etching near the window area and released the hydrocarbons from the structure of the plastic material only on the surface, and then the bubbles began to move during the coating process transparent with UV polymerization. To prove the possible effects of oil contamination under pressure, the defective “O” ring was reassembled and batches were produced with an increase in the mold temperature, and the window area was investigated. As shown by optical microscopy inspection, small circles were detected on the white surface of the plastic, and this cannot come from a normal amorphous structure of the material (Figure 15).

Some solutions to reduce then to eliminate the occurrence of the failures were found as follows. A defect rate indicator was used to measure the results of all counter measures and improvements actions, based on the report between the number of parts that contain one or more fish-eye defects and total parts checked, in percentage. As a short-term improvement action, the tempering step was implemented at 80 to 85 degrees Celsius during 2 h of the injected parts before the primer painting process. It leads to reducing of the defect rate from 80% to 50%. Furthermore, the changing of the cooling system of the injection molding tool from oil to water led to reducing of the defect rate from 50% to 0.9%. Variation of the defect rate of 0.9% generates the need to investigate the plastic parts, and new parameters in injection molding reduced the scrap rate from 0.9% to 0.05%.

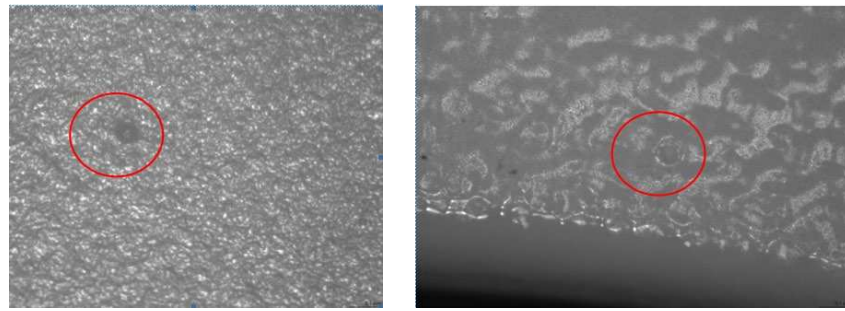
**Figure 15.** Optical microscopy inspection of the parts resulted using an increased mold temperature.
