## Aspects regarding the extension and consolidation of a house located on a sloping plot of land

**Abstract.** When the land available for a construction is in slope, with a high degree, there can be a series of problems related to geotechnical data and execution difficulties, considering the foundations and the structure itself. The grade of difficulty is considerably increased when an extension or attic is intended to be design and build. The paper is presenting some considerations to this problem, taken into account a study case – extension of an existing structure for a family house.

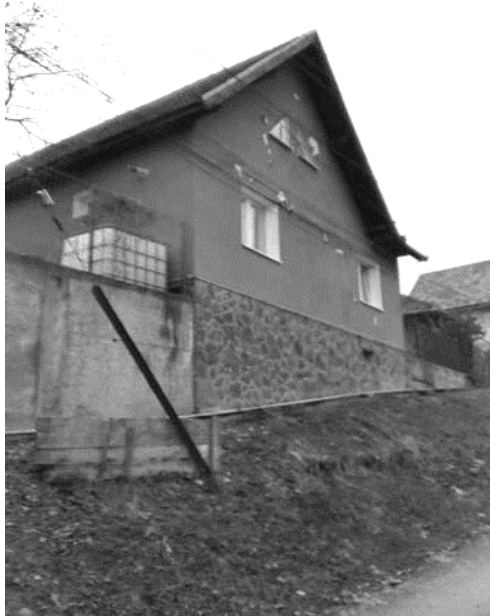
Figure 1. Left side facade, first support wall.

This paper is presenting some considerations upon the extension of the existing house build on a sloped plot. There is presented a study case for an extension with an attic for an existing construction located in Săcele city (Braşov county), on a ground with slope ~ 35 degrees (figure 1, 2). Through the design theme, the owner wants to transform a family house into a two apartments house. It is also desired that the ground floor does not change its current functions or dimensions. The project respected this design theme, so that the same wall partitioning was kept on the ground floor, the extension area having more of an access role to the attic.

According to the design theme, the owner wants to build an extension and an attic for an existing house. The existing height regime is ground floor and will become a ground floor with an attic, increasing the total height of the construction. As presented in figures 1 and 2, there are two retaining reinforced

concrete walls: one located in the area of the house and one in the back of it (which is approximately at the level of the ground floor of the existing house) [3]. Also, in figures 3 and 4 there are presented the facades of the existing building.

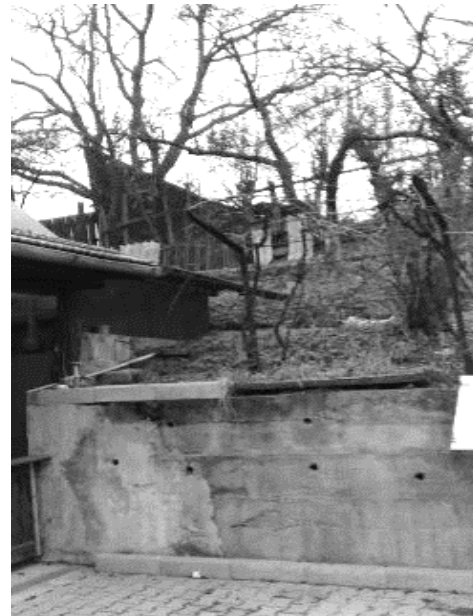
Figure 2. The second support wall.

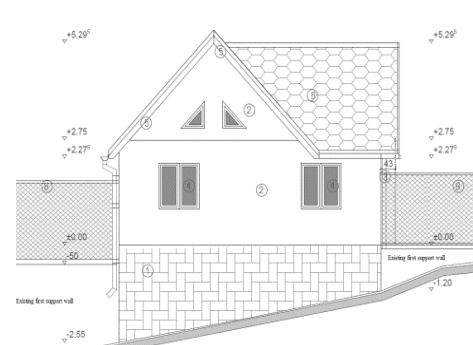
Figure 4. Existing left facade.

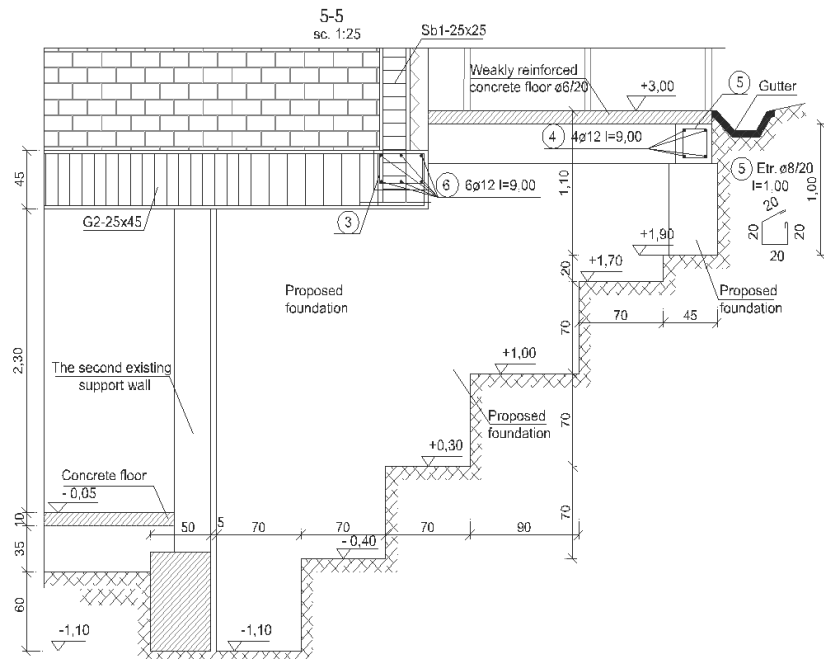
Figure 8. Detail 5 of the foundation.

Between the existing construction and the second retaining wall there is a passage corridor, between the courtyard in front of the house and the land behind the house, which the owner wanted to keep. For this reason the second retaining wall had to be kept in its original form. The extension was necessary, to support, on the continuous foundations located behind the retaining wall. In order not to introduce additional forces from pushing the ground due to the loads from the extension, the foundation for the extension was made in minimum steps of length, the starting quota of the foundation coinciding with that of the retaining wall. Above the passage corridor, the floor above the ground floor of the extension was provided, thus forming a kind of passage tunnel. Normally the ends of the tunnel should have been blocked with the passage of the continuous foundation. The solution of this problem consisted in the support of the main beams G2-25x45, G2-25x45 on the left on the pillars S1-60x25, S2-25x50 respectively S4-50x50, and on the right directly on the simple foundation block, the beams being connected to the foundation belt from the beginning (figure 8) [13].

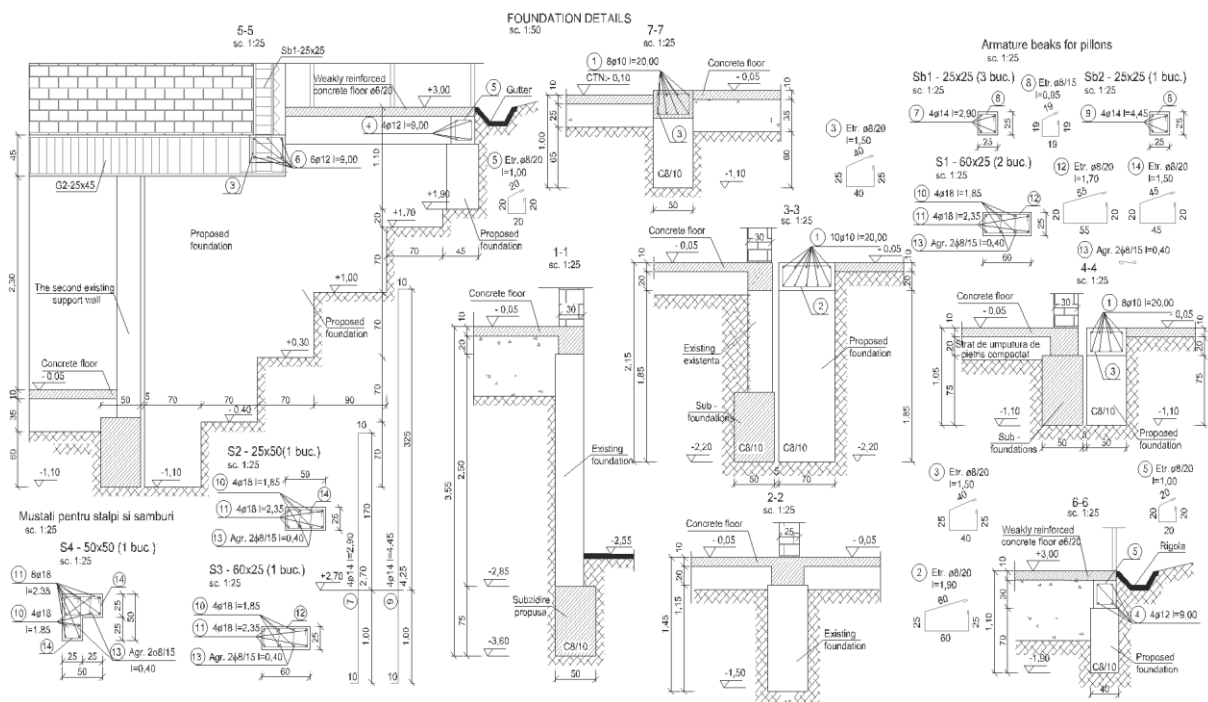
Figure 9. Foundation details.
