# Study on Effectiveness of Regional Risk Prioritisation in Reinforced Concrete Structures after Earthquakes

**Abstract:** Depending on the characteristics of the existing buildings, earthquakes can cause damage at different levels and have a significant impact on the environment. The structural damages after the earthquakes have shown the importance of analysing both the existing and the damaged buildings. In this study, the Turkish rapid seismic assessment method, which was used for the existing building stock before a possible earthquake, was applied to the damaged reinforced concrete (RC) buildings after the 6 February earthquakes in Kahramanmaraş (Türkiye). The building data were used as a result of field observations in the provinces of Adıyaman, Hatay, and Kahramanmaraş, where the greatest destruction was caused by these earthquakes. Five RC buildings from each province were considered. The rapid assessment method was applied to a total of 15 buildings with different levels of damage. For this purpose, pre-earthquake images of the buildings were obtained, and an earthquake performance score was obtained for each building, taking into account the sustained damage during the

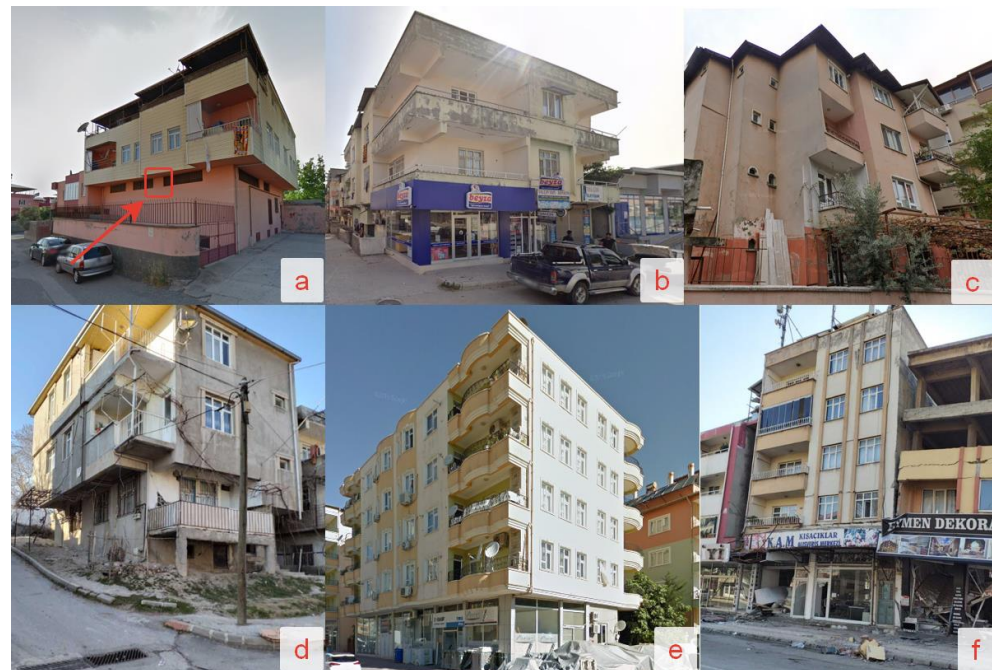
Application examples of the parameters considered in this study on the existing building stock in the earthquake region are shown in Figure 11. Google Street [72] was used to obtain images.

**Figure 11.** (a) Short column, (b) soft/weak storey, (c) plan irregularity, (d) hill/slope effect, (e) heavy overhang, (f) adjacent buildings.

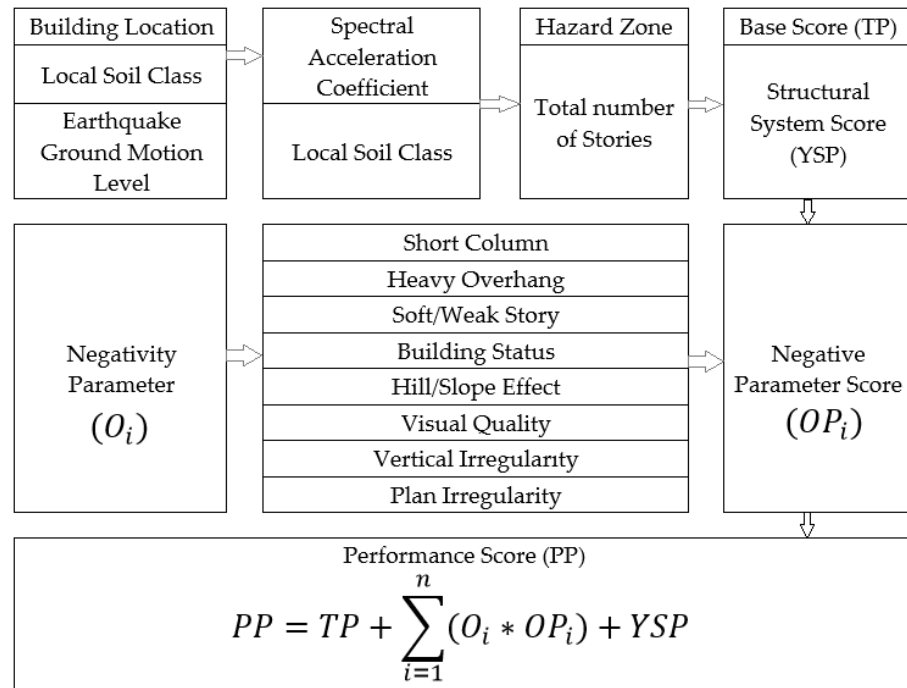
building with a lower score has a higher risk priority. A flowchart of this method is shown in Figure 12.

Figure 12. Flowchart of the rapid assessment method for RC buildings.

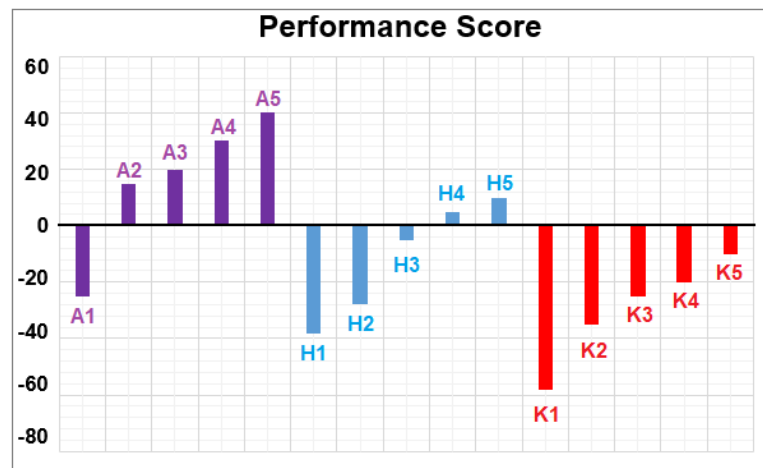
The performance scores obtained for all buildings are shown in Figure 15. The average performance score of the RC structures considered was obtained as  $-8.2$ . The scores of a total of seven buildings are above this score and the others are below the average value. While the building with the highest risk is K1 in Kahramanmaraş Province, the building with the lowest risk priority is A5 in Adıyaman Province. The fact that the building with the most different structural irregularities is K1 reveals the accuracy of the results obtained. The fact that performance scores in Adıyaman Province are higher than in other provinces is due to the earthquake hazard of the province. While the buildings in Hatay and Kahramanmaraş Provinces are in the I earthquake hazard zone, the buildings in Adıyaman Province are in the II earthquake hazard zone.

Figure 15. Performance scores of the RC buildings.
