INTEGRITY OF WELDED JOINTS MADE OF ALLOY NiCr21Mo INTEGRITET ZAVARENIH SPOJEVA LEGURE NiCr21Mo

Originalni naučni rad / Original scientific paper
UDK /UDC:

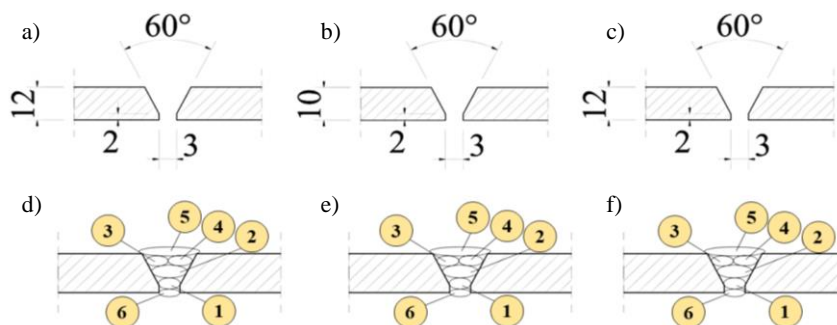
Figure 1. Groove geometries for: a) NiCr21Mo-NiCr21Mo BW; b) NiCr21Mo-P355GH BW; c) NiCr21Mo-X2CrNiMo17-12-2; filling plans for: d) NiCr21Mo-NiCr21Mo BW; e) NiCr21Mo-P355GH BW; f) NiCr21Mo-X2CrNiMo17-12-2 BW.

In order to avoid preheating requirement for P355GH, plates were 10 mm thick only for joint with NiCr21Mo. Plates of the other two BW joints were 12 mm thick with no preheating requirements. Welding was performed in the PA (horizontal) position. Argon (Ar) flow rate (as a backing) during root welding was in the range 7-9 l/min, while Ar flow rate (as shielding gas) was in the range 5-8 l/min (both of 100 % purity). Filler material diameter of Ø1.6 mm was used for root welding (2 layers), while Ø2.0 mm was used for filling the grooves for all 3 joints. Figure 1 shows the groove sizes of all three BW joints, groove geometries along with the groove filling plan.

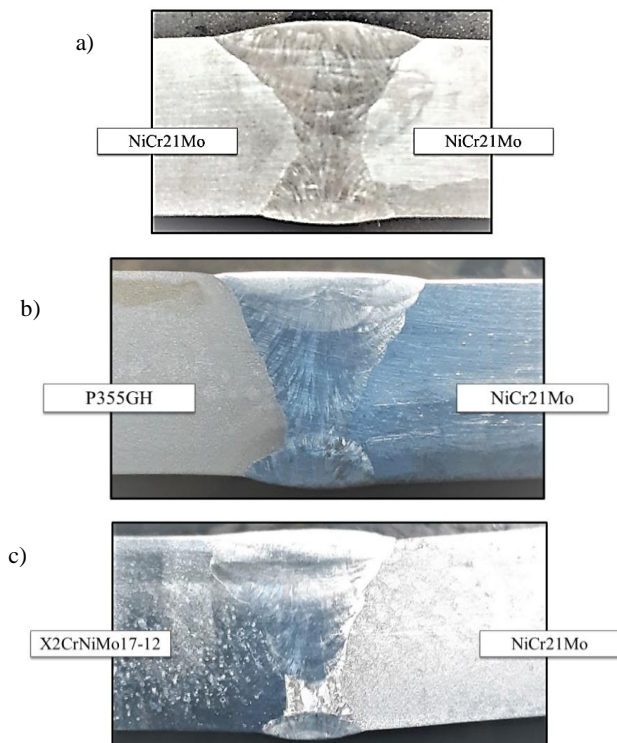
Figure 2. BW joints made of: a) NiCr21Mo; b) NiCr21Mo and P355GH; c) NiCr21Mo and X2CrNiMo17-12-2 (magn. ×2).

Macrostructures of all three welded joints (with magnifications $\times 2$) are shown in Fig. 2.

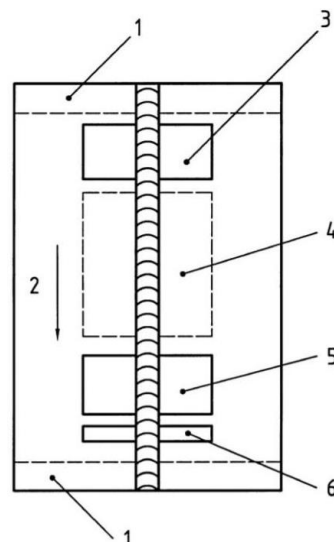
Figure 3. Welded plate: 1) discardable section (width 25 mm); 2) welding direction; specimens for: 3) tensile and bend tests; 4) impact test; 5) tensile and bend tests; 6) hardness measurements, macro- and microstructural analysis.

Specimens were taken from all three welded plates according to EN ISO 15614 standard recommendation. This standard defines the procedure and locations for specimens intended for a certain type of mechanical test, as given in Fig. 3. Tests provided an insight into the welded joint characteristics, as will be presented in the following.

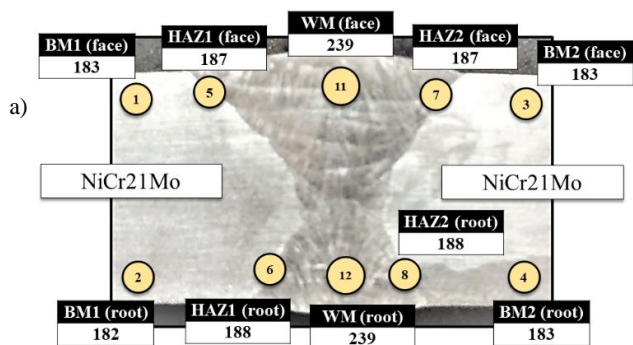
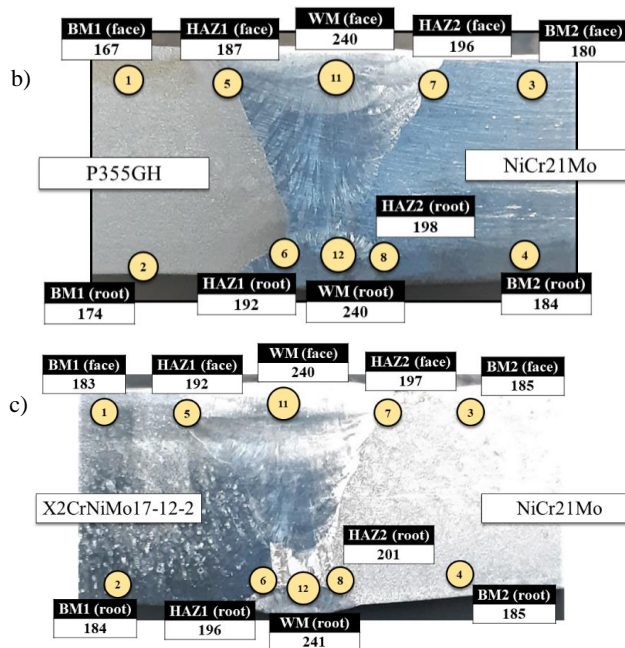
Figure 5. Hardness measurements: a) BW joint made of NiCr2Mo; b) BW joint P355GH and NiCr21Mo; c) X2CrNiMo17-12-2.

Hardness measurements were performed on 12 locations on each welded joint region (i.e. both parent materials, HAZ regions and weld metal) on all three BW joints, using HV10 method. Acceptance criteria was according to the requirements of ISO 156014-1 standard. Etching was carried out with Nital 4 % solution (nitric acid). The results of hardness measurements and measuring points are shown in Fig. 5. The hardness values increase in weld metal zone in comparison to the HAZ regions in all three cases. This was expected, considering the higher strength of the filler material compared to parent material. Also, the hardness values in HAZ were higher than in the parent material.

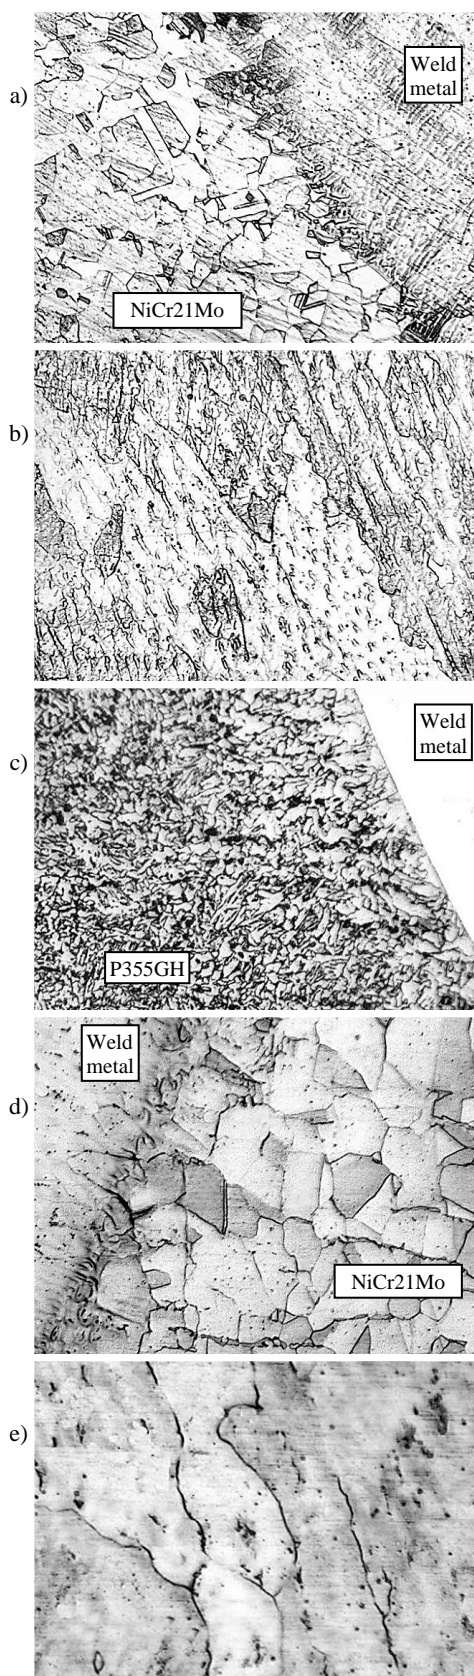
Figure 6. Microstructures of: a) fusion line of NiCr21Mo-NiCr21Mo BW; b) weld metal of NiCr21Mo-NiCr21Mo BW; c) fusion line of NiCr21Mo-P355GH BW (on the P355GH side); d) fusion line of NiCr21Mo-X2CrNiMo17-12-2 BW (on X2CrNiMo17-12-2 side); e) weld metal of NiCr21Mo-X2CrNiMo17-12-2 BW.

Microstructure analysis took place in order to check for potential microstructural changes in the critical regions of the weld, mainly HAZ and fusion line region, as well as in the weld metal itself. Acceptance criteria of welding defects were according to ISO 15614-1. Magnification is 400x. In Figure 6a and 6b presents microstructures in the vicinity of fusion line and HAZ region, respectively, on the first BW (weld made of NiCr21Mo). The macrostructure of welded joint shows no unacceptable defects (such as inclusions, undercuts, lack of fusion, cracks, etc.) Microstructural analysis reveals a fine-grained austenitic structure, along with twinning effect. Coarser austenite grains found near the weld face are not observed in any welded joint regions. Figure 6c shows microstructures on the second BW (weld made of NiCr21Mo-P355GH) in the vicinity of the fusion line on the P355GH side. Although P355GH has fine-grain ferritic-pearlitic microstructure, a ferritic-bainitic microstructure can be observed on the top (face) side of the HAZ, while closer to the root and the fusion line, it is bainitic. Dendrite formation of austenitic weld metal structure can be observed along with the presence of carbides. Figure 6d and 6e show microstructures of the third BW (weld made of NiCr21Mo-X2CrNiMo17-12-2) in the vicinity of the fusion line on the NiCr21Mo side and the weld metal, respectively. Analysis reveals not-so-fine-grained austenitic structure of the HAZ, with a trend of being coarse-grained near the fusion line, and a twinning effect. Fine-grained austenite was observed on HAZ closer to X2CrNiMo17-12-2, along with twinning effect. A nonhomogeneous weld metal microstructure can be observed in this case. Dendrite formation of the austenitic structure can be observed along with the presence of carbides.
