DAMAGE ANALYSIS AND RESTORING OF STRUCTURAL INTEGRITY OF PELTON RUNNER AFTER REPAIR WELDING: CASE STUDY

Originalni naučni rad / Original scientific paper

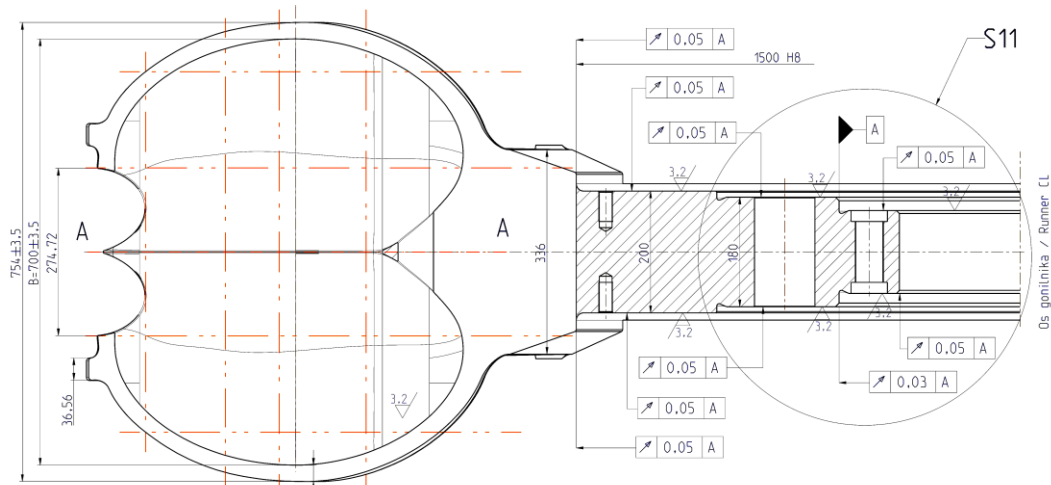
Figure 2. Geometry of Pelton runner blade.

To understand this particular problem regarding the cracking of the blade, this section begins with the Pelton runner blade (characteristic's) geometry, given in Fig. 2. Notably, blade thickness is just 4 mm exposed to extreme conditions with expected cavity and high loading due to water flow causing high stress at the blade edge.
