# Novel Method for Failure Modes Detection in UV-Cured Clear Coated Polymer for Automotive Interior Mechatronic Devices

Ion Cristian Braga, Razvan Udriou and Anisor Nedelcu

<https://doi.org/10.3390/polym14183811>

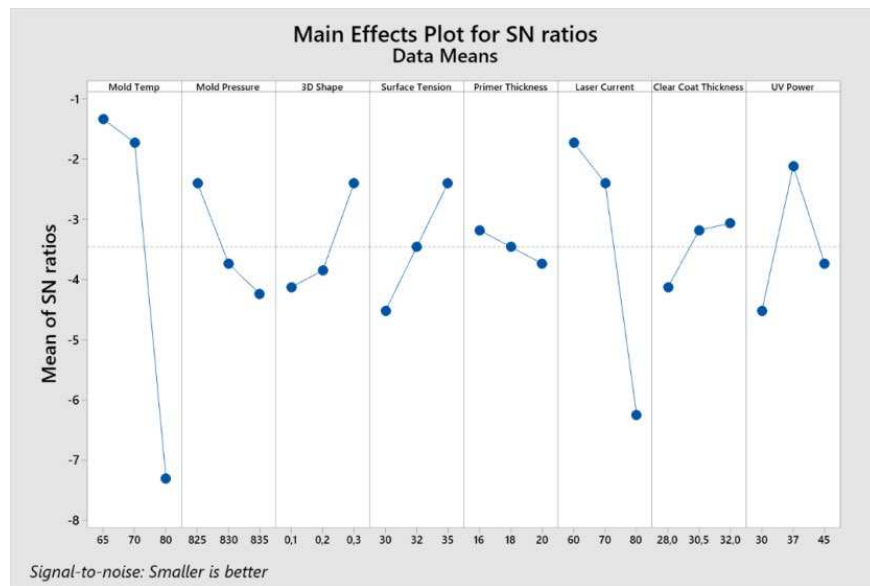
**Figure 13.** Main effects plot for Signal to Noise Ratios.

As can be seen, based on the ranking from the Table 4, but also in Figure 13, two factors have the most influence in fish-eyes defect occurrence: the mold temperature and the laser engraving current. In third and fourth places, the UV power and the surface tension could be selected as medium influence.

Therefore, based on the selected parameters and their levels, the DoE shows the optimal parameters combination to achieve the minimum quantities of the “fish-eye” defects as following: Mold Temp level 1, Mold pressure level 1, 3D Shape level 3, Surface Tension level 3, Primer thickness level 1, Laser current level 1, Clear Coat thickness level 3, and UV Power level 2. It must be underlined that the surface defects will be reduced by using the optimal combination, but not eliminated at all.
