23 European Conference on Fracture - ECF23

# Residual life of a historic riveted steel bridge - engineering critical assessment approach

#### 3.1. Case study – 1925 rivetted steel bridge

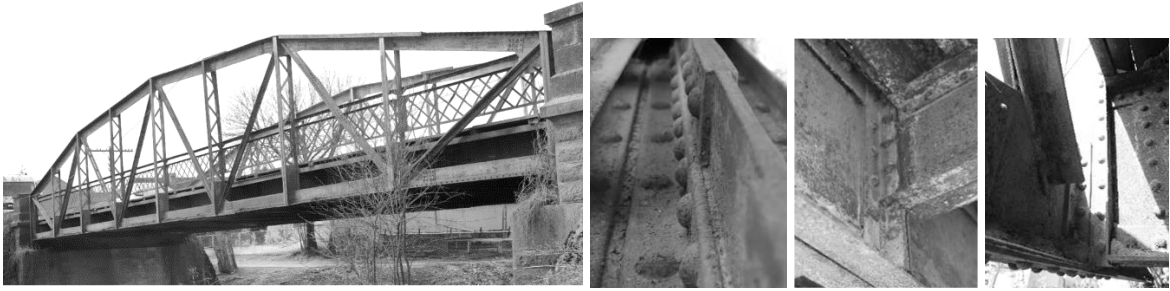
Fig. 3. Existing structure – views and joints details

The bridge is a rivetted type, build around year 1925 in Transylvania and from the geometry point of view, having a parabolic truss main beam structure, with a span of  $L = 27.00$  m and a width of 6.25 m (road for only 5.25 m). The structure is similar to other bridges built in the same period: heavy deck (with pavers) consisting of Zores profiles arranged on a network of beams consisting of stringers and cross girders with a bracing system ensuring the spatial stability of the structure. The elements are made of composed cross section – L type profiles with additional steel plates (figure 3).

Due to bridge condition and the lack of maintenance, the most frequent flaw type discovered after visual inspected the structure, was the surface type flaw (figure 3 and 4).
