# Comparative Surface Quality of Maple (*Acer pseudoplatanus*) Cut through by CNC Routing and by CO<sub>2</sub> Laser at Different Angles as Related to the Wood Grain

**Abstract:** The evaluation of surface quality is an important criterion to understand the effect of the cutting angle in relation to the grain and of the processing tool on wood. This paper examines, in a comparison, the surface quality of maple cut through by CNC and CO<sub>2</sub> laser, for different angles with regard to the wood grain: 0°, 15°, 30°, 45°, 60°, 75°, and 90° and at different feed speeds of the CNC router: 2; 2.5; 3; 3.5 and 4 m/min. The direction of processing as related to the grain was a more significant factor in comparison with the feed speed when CNC was used, with best options for 0°, 90° and 75° and worst for 15°, where fuzzy grain was predominant, followed in order by 30°, 45°, and 60°, where pull-out material prevailed. The laser smoothed the core roughness, R<sub>k</sub>, with no significant differences as related to the wood grain direction and enhanced an anatomical waviness earlywood-latewood, with the earlywood processed deeper. As the cutting advanced from along to across the grain

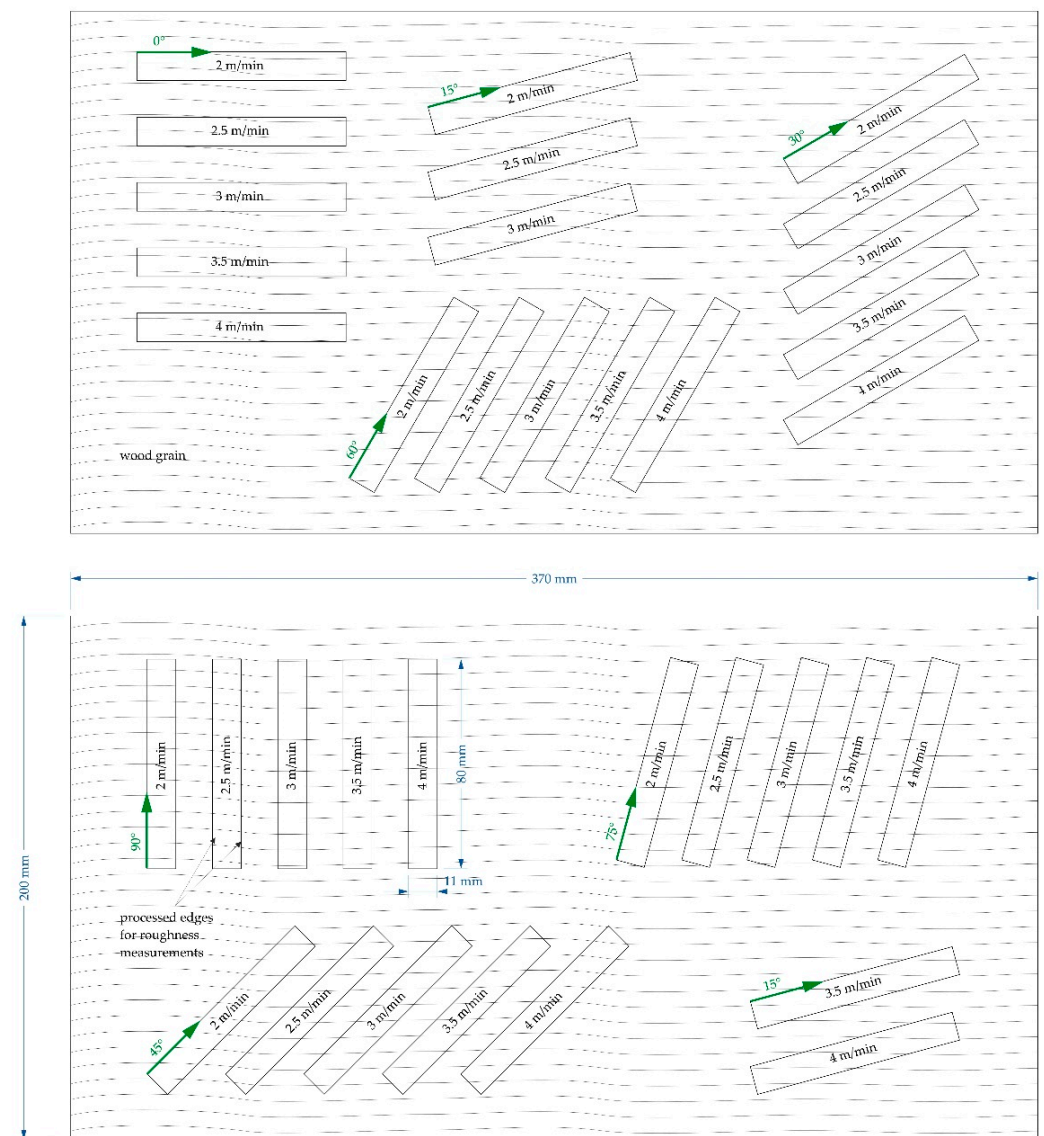
**Figure 1.** Cutting model for CNC routing of samples cut out from maple panels.

One sample was cut out for each combination of feed speed (2 m/min, 2.5 m/min, 3 m/min, 3.5 m/min, and 4 m/min) and cutting angle as related to the grain ( $0^\circ$ ,  $15^\circ$ ,  $30^\circ$ ,  $45^\circ$ ,  $60^\circ$ ,  $75^\circ$ , and  $90^\circ$ ), so that a total of 35 samples processed on both edges were provided for investigation (Figure 1).

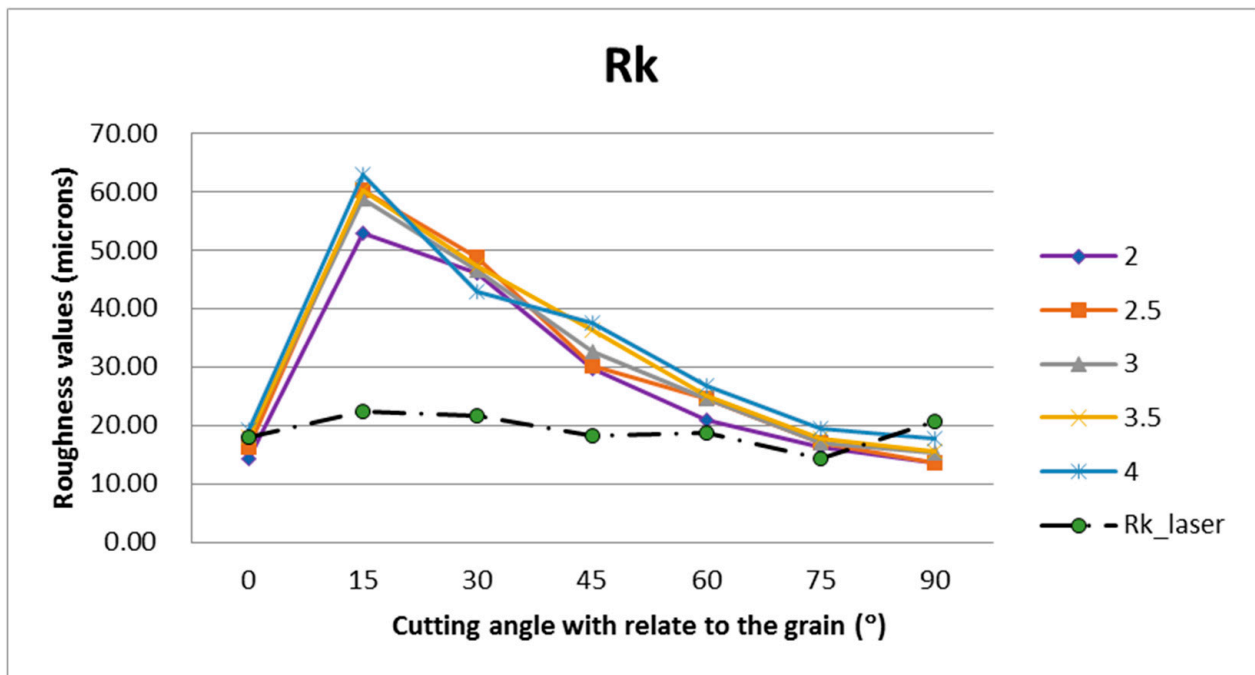
**Figure 3.** The variation of the roughness parameter Rk (mean values) for different feed speeds (m/min) with the cutting angle at CNC routing. With dashed line, Rk values for laser processing.

If anatomy is not removed for wood surfaces, then  $R_k$  appears to be the most useful indicator of the processing roughness because  $R_k$  is the parameter least affected by the presence of wood anatomy [1,25,27–29]. The parameter  $R_k$  is depicted in Table 1 and Figure 3. It shows an increase with the feed speed, with the lowest values for 2 m/min. A value of 2 m/min feed speed was also found suitable for a reduced surface roughness by [12]. The core roughness,  $R_k$ , had the highest values for a cutting angle of  $15^\circ$ , followed by  $30^\circ$  and then  $45^\circ$ ,  $60^\circ$ ,  $75^\circ$ ,  $0^\circ$ , and  $90^\circ$ . When analyzed with ANOVA and Duncan test, the feed speed seems to have a less significant effect on the processing roughness in comparison with the cutting angle with respect to the grain. The result was similar to the observations of [1] which studied the processing of larch. For example, when processing along the grain,  $R_k$  increased with app. 30% for a feed speed of 4 m/min, compared with 2 m/min. However, changing the cutting angle from  $0^\circ$  to  $15^\circ$ , has increased the processing roughness more than triple, for  $u = 2\text{ m/min}$  (Table 1), as for larch in the study of [1]. Lowest  $R_k$  was obtained for the  $90^\circ$  angle, but the difference in quality ( $R_k$ ) between  $0^\circ$ ,  $75^\circ$ , and  $90^\circ$  was not significant whatever the feed speed, as tested with ANOVA and DUNCAN test ( $p < 0.05$ ) in Table 1.

No significant differences in  $R_k$  between CNC cutting and laser processing were found for angles: 0°, 60°, and 75°. The 15° cutting angle produced the highest differences between the two processing methods. The surface processed with the CNC and  $u = 2$  m/min was significantly rougher (tested with ANOVA), than the one processed by laser, more than double:  $R_{k\_CNC} = 52.82 \mu\text{m}$  and  $R_{k\_laser} = 22.47 \mu\text{m}$ . Processing with the CNC caused raised fibers, quantified by  $R_{pk} = 41.92 \mu\text{m}$ , as compared with laser with  $R_{pk} = 13.28 \mu\text{m}$ . In the case of a cutting angle of 30°, the difference in processing roughness between the CNC ( $u = 2$  m/min) and laser is maintained, the surface being rougher for CNC more than double ( $R_k = 46.11 \mu\text{m}$  for CNC and  $R_k = 21.59 \mu\text{m}$  for laser). The processing at a 45° angle has diminished the quality difference between laser and CNC. Processing with the CNC ( $u = 2$  m/min) caused 1.6 times rougher surfaces. It can be concluded that changing the cutting angle to 15°, 30°, and 45° is causing significant differences in quality between the two processing tools. At 90°, cutting with laser caused a 50% rougher surface than when cutting with CNC ( $u = 2$  m/min). A possible reason may be the fact that laser reveals more anatomical details in comparison with the CNC and they bias the highest concentration of data points in evaluating  $R_k$ , in other words, anatomical irregularities may artificially increase  $R_k$ .

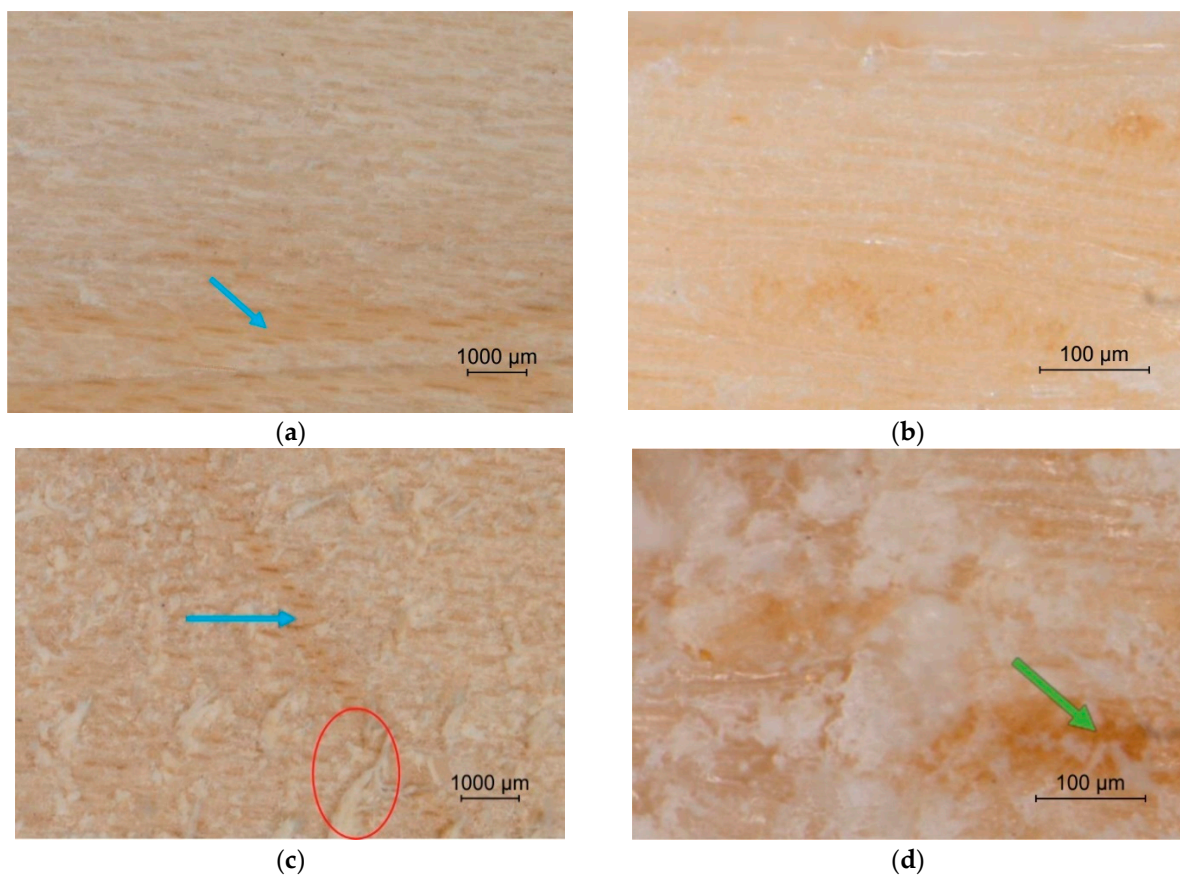
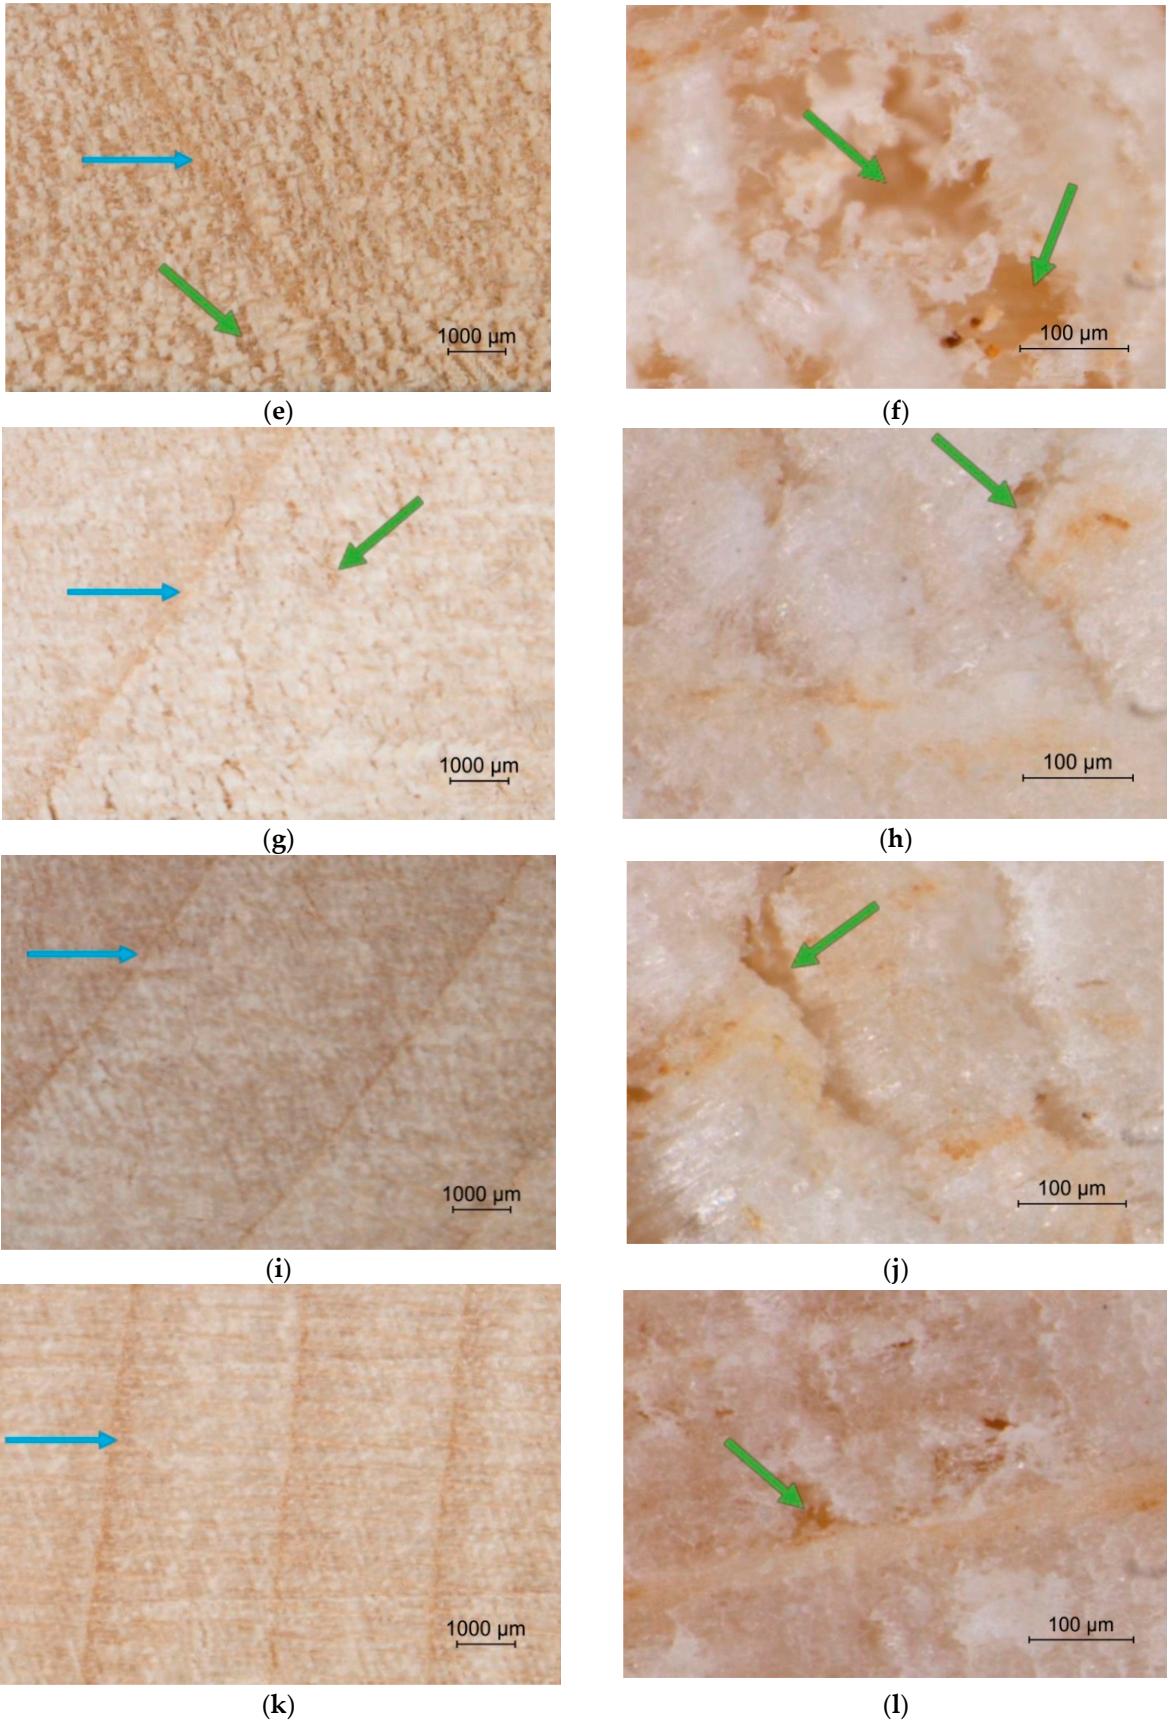
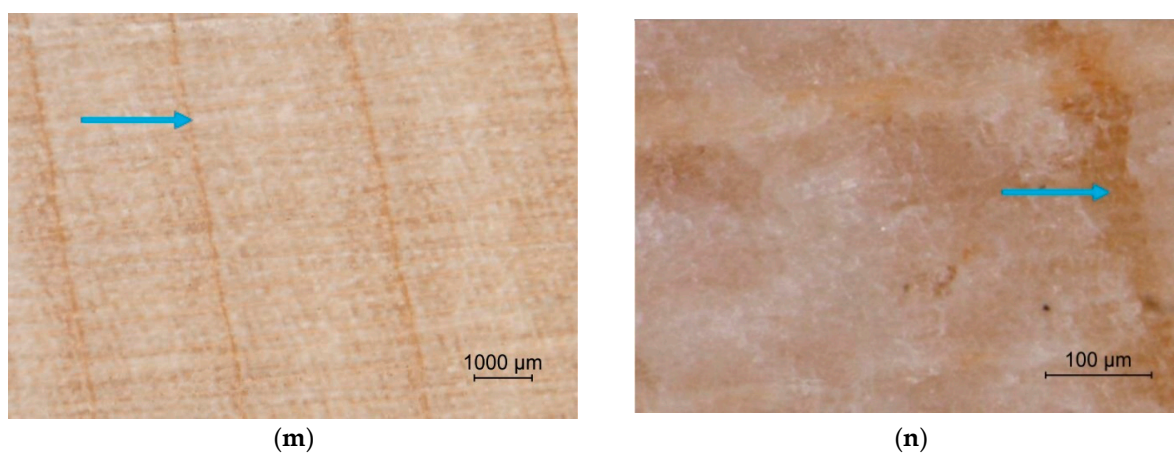
**Figure 4.** Microscopic images of CNC processed maple ( $u = 2$  m/min) at different angles in relation to the grain and two magnifications,  $22.5\times$  and  $405\times$ : (a,b)  $0^\circ$ ; (c,d)  $15^\circ$ ; (e,f)  $30^\circ$ ; (g,h)  $45^\circ$ ; (i,j)  $60^\circ$ ; (k,l)  $75^\circ$ ; (m,n)  $90^\circ$ . Blue arrows point to the growth limit. Green arrows mark deep gaps. Raised wood fiber encircled with red.

The presence of fuzzy grain for cutting at  $15^\circ$  is also shown by  $R_{sk}$  in Figure 7. According to [21], surfaces with a positive skewness,  $R_{sk} > 0$  have fairly high peaks that protrude above a smoother plateau and in this particular case are an indication of predominant fuzziness. A similar observation was made for larch processed by CNC with identical cutting parameters and at  $15^\circ$  as related to the grain [1]. An increase in fuzziness was also observed by [6] for oak processed at narrow angles ( $10^\circ/20^\circ$ ) and this phenomenon was more pronounced in lower-density areas (earlywood), while denser areas (latewood) displayed a good surface aspect. Indeed, the wood zone at the growth limit (marked by blue arrows) and characterized by a higher density, looks less affected by fuzziness in Figure 4, for all cutting angles.

Another noted effect was the occurrence of occasional deep surface gaps. This was observed in the micrographs beginning with a  $15^\circ$  angle (Figure 4c,d), but with a maximum happening for  $30^\circ$  (Figure 4e,f) then  $45^\circ$  (Figure 4g,h), and much less in  $60^\circ$  (Figure 4i,j). In the micrographs, the surface gaps are shown by green arrows. The same effect is visible in the profiles of Figure 5, where examples of deep surface gaps are encircled with green. These observations were also confirmed by the values of  $R_{vk}$  in Figure 8 and  $R_v$  in Figure 9.  $R_{vk}$  is a measure of isolated surface gaps caused by material being pulled out during processing and/or anatomical cell lumens that exceed the depth of the processing marks [1,28].

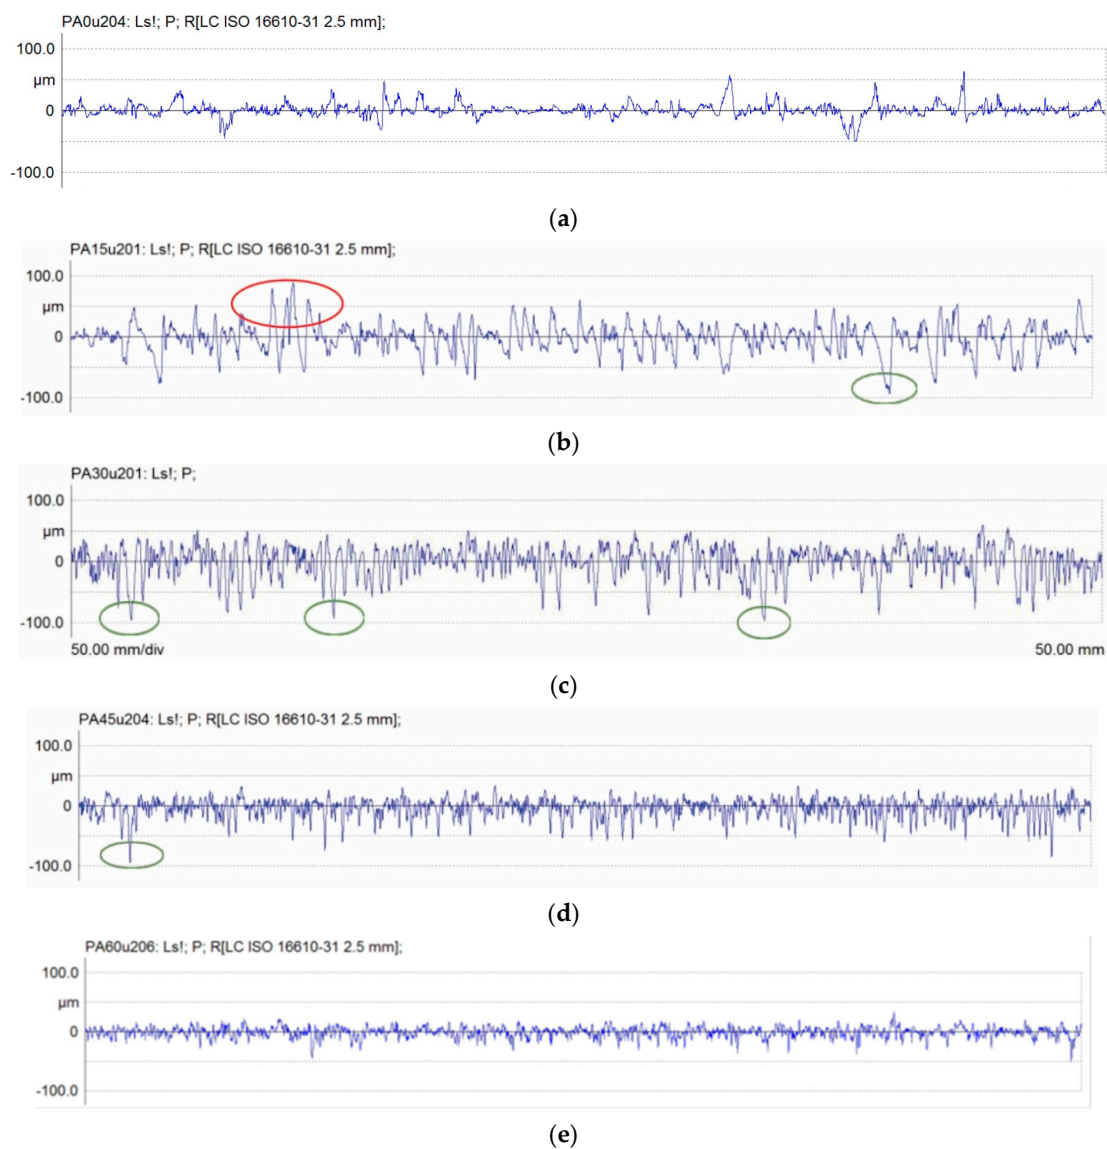
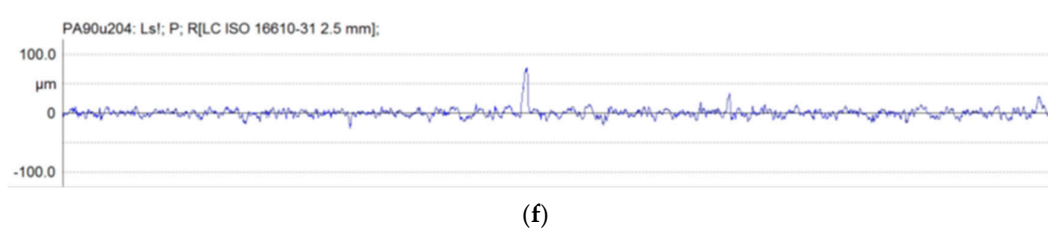
**Figure 5.** Comparison of roughness profiles from CNC routed surfaces ( $u = 2$  m/min): (a) along the grain; (b) at  $15^\circ$  (fuzzy grain encircled with red); (c) at  $30^\circ$ ; (d) at  $45^\circ$ ; (e) at  $60^\circ$ ; (f) at  $90^\circ$  as related to the grain. Highlighted with green are surface gaps.

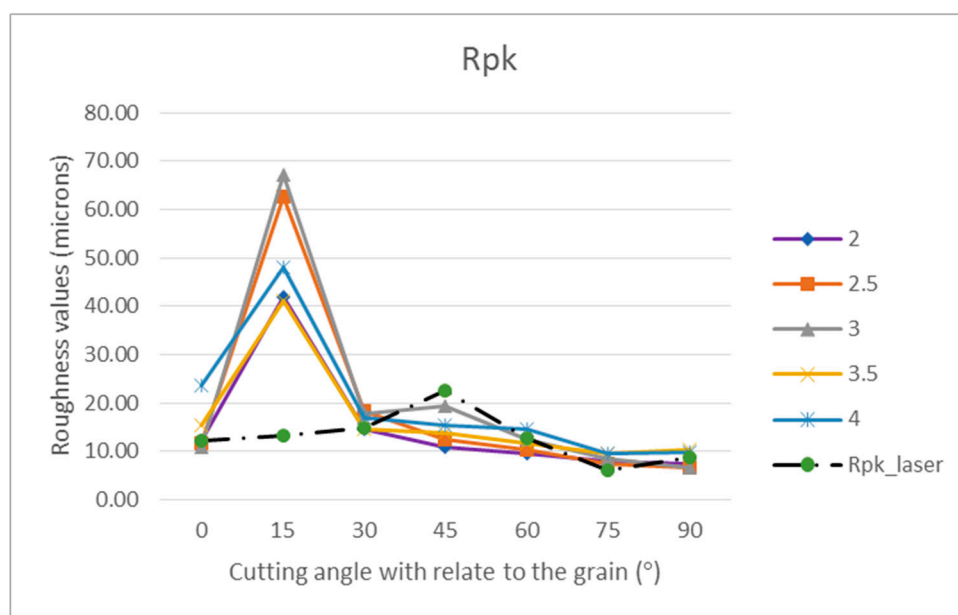
**Figure 6.** The variation of the reduced peak height parameter, Rpk (mean values), for various feed speeds (m/min), with the cutting angle at CNC routing. With dashed line, Rpk for laser processing.

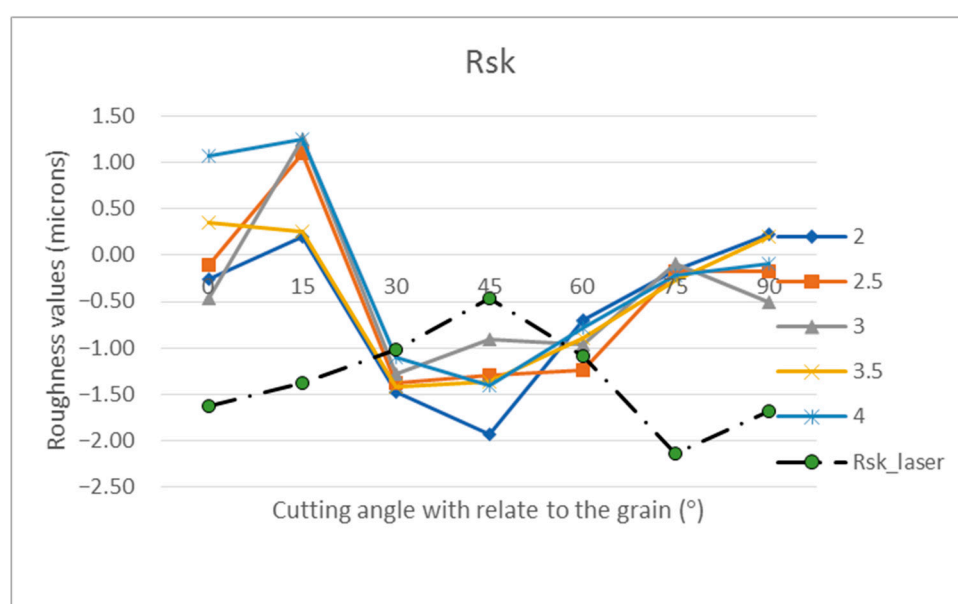
**Figure 7.** The variation of the skewness of the profile, Rsk (mean values), for various feed speeds (m/min) with the cutting angle at CNC routing. With dashed line, Rsk for laser processing.

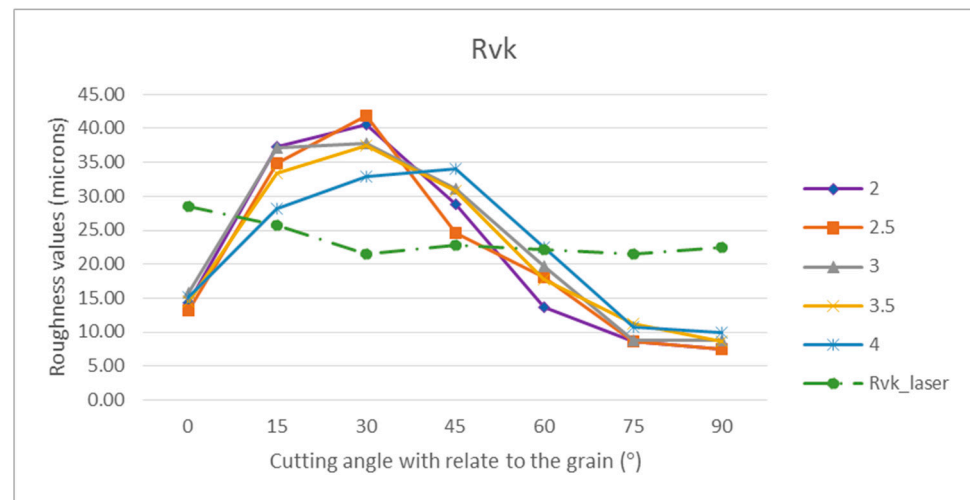
**Figure 8.** The variation of the reduced valley depth parameter, Rvk (mean values), for various feed speeds (m/min), with the cutting angle at CNC routing. With dashed line, Rvk for laser processing.

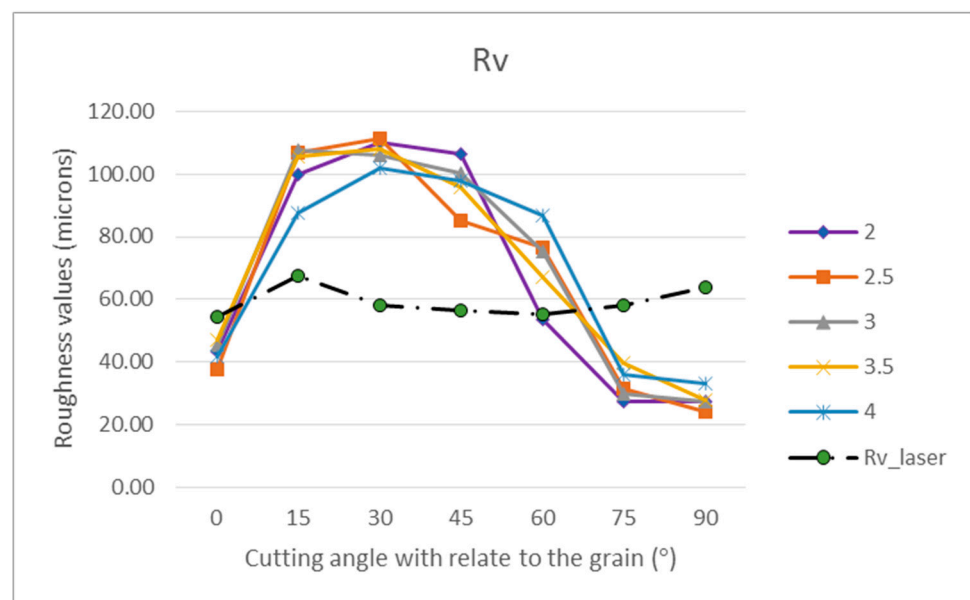
**Figure 9.** The variation of the largest absolute profile valley depth, Rv (mean values), for various feed speeds (m/min), with the cutting angle at CNC routing. With dashed line, Rv for laser processing.

It was interesting to observe that the parameter which measures the deepest irregularity within a profile,  $R_v$  (Figure 9), showed no significant difference between the different cutting angles (checked with ANOVA), which may be an indication that it captured the depth of the lumen vessels from earlywood, in all cases of cutting (the majority of measurements were in the range of 55–65 microns). If this is the case,  $R_v$  for CNC cutting at  $15^\circ$ ,  $30^\circ$ ,  $45^\circ$ , and  $60^\circ$  confirms the presence of pull-out material, as discussed before. In other words, processing with laser can contribute to a better understanding and interpretation of surface morphology when processing takes place by CNC. For  $75^\circ$  and  $90^\circ$ ,  $R_v$  at laser processing shows a deeper pore penetration than along the grain. On the contrary, processing by CNC, particularly for the crosscut directions, has filled the pores with dust, as discussed before, which lowered  $R_v$ .

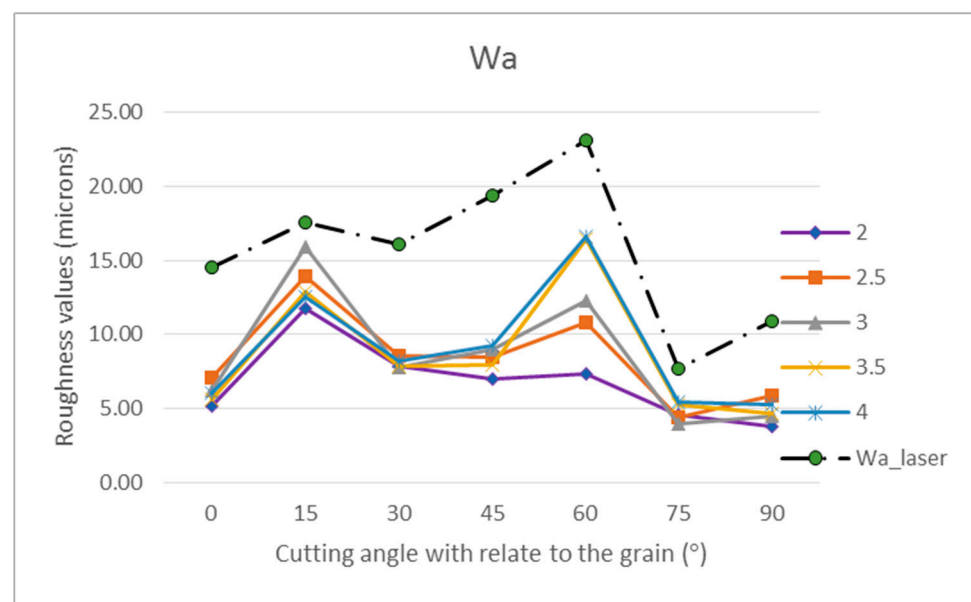
**Figure 10.** The variation of the mean arithmetic waviness, Wa (mean values), for various feed speeds (m/min), with the cutting angle at CNC routing. With dashed line, Wa for laser processing.

Referring to irregularities of larger scale wavelength, the lowest waviness (Wa) was remarked for  $u = 2$  m/min (Figure 10). High waviness in comparison with other cutting angles is produced for  $15^\circ$  and  $60^\circ$ , especially for high cutting speeds. Similar observations were made on larch by [1].

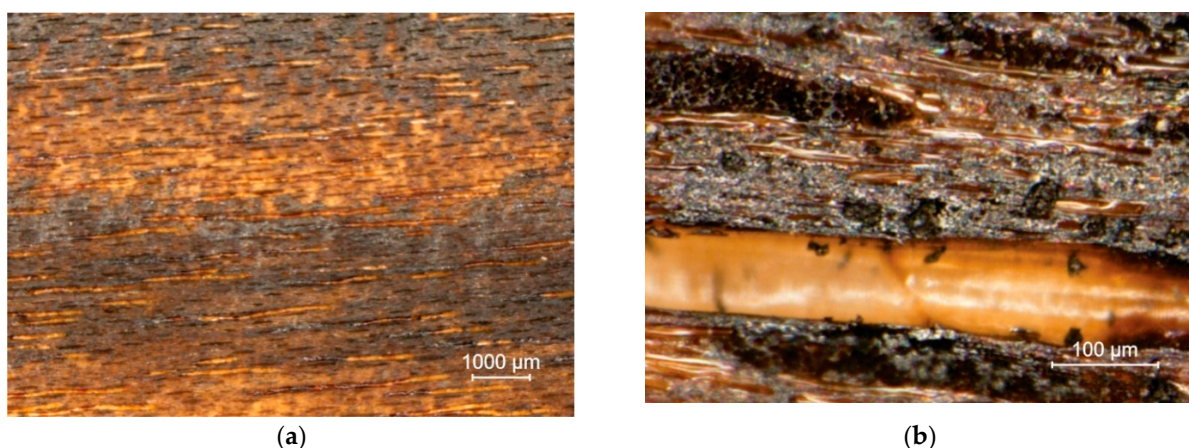
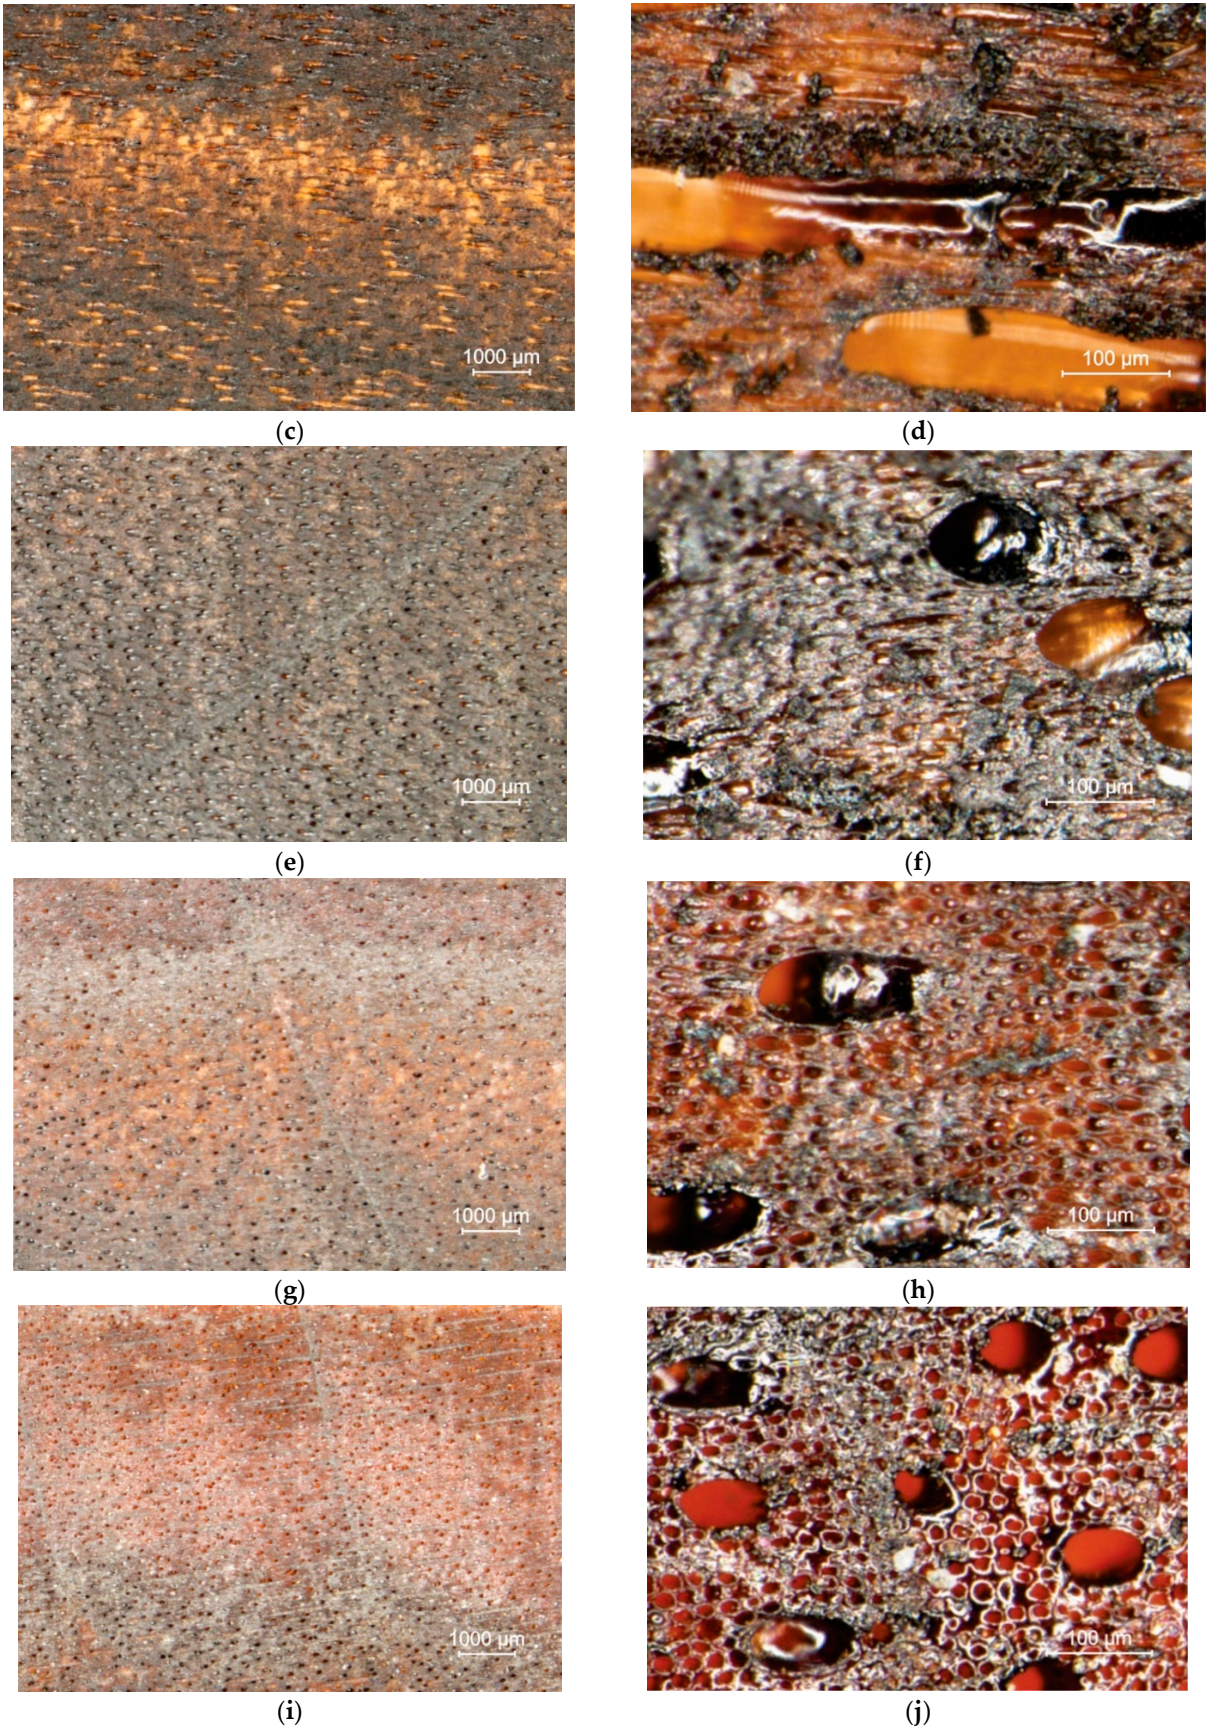
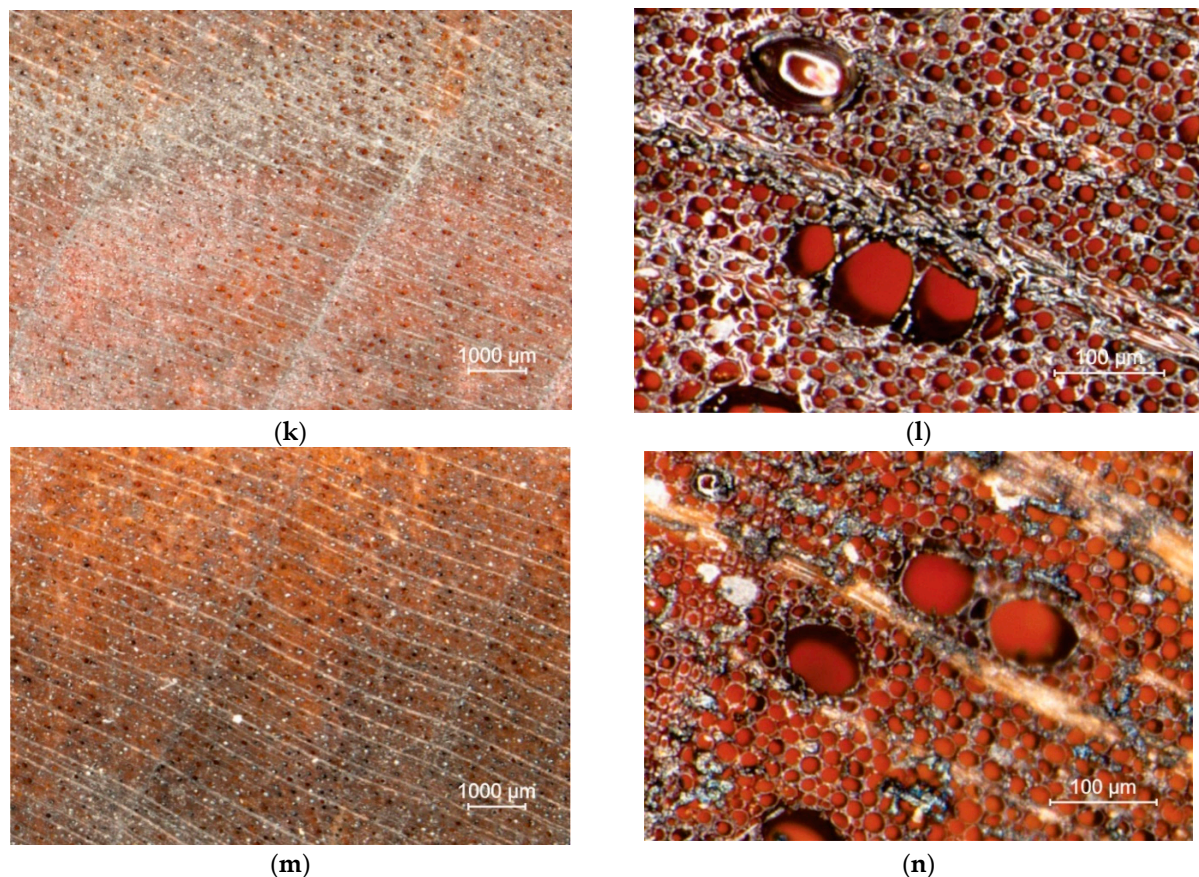
**Figure 11.** Microscopic images of laser processed maple at different angles in relation to the grain and two magnifications, 22.5× and 405×: (a,b) 0°; (c,d) 15°; (e,f) 30°; (g,h) 45°; (i,j) 60°; (k,l) 75°; (m,n) 90°.

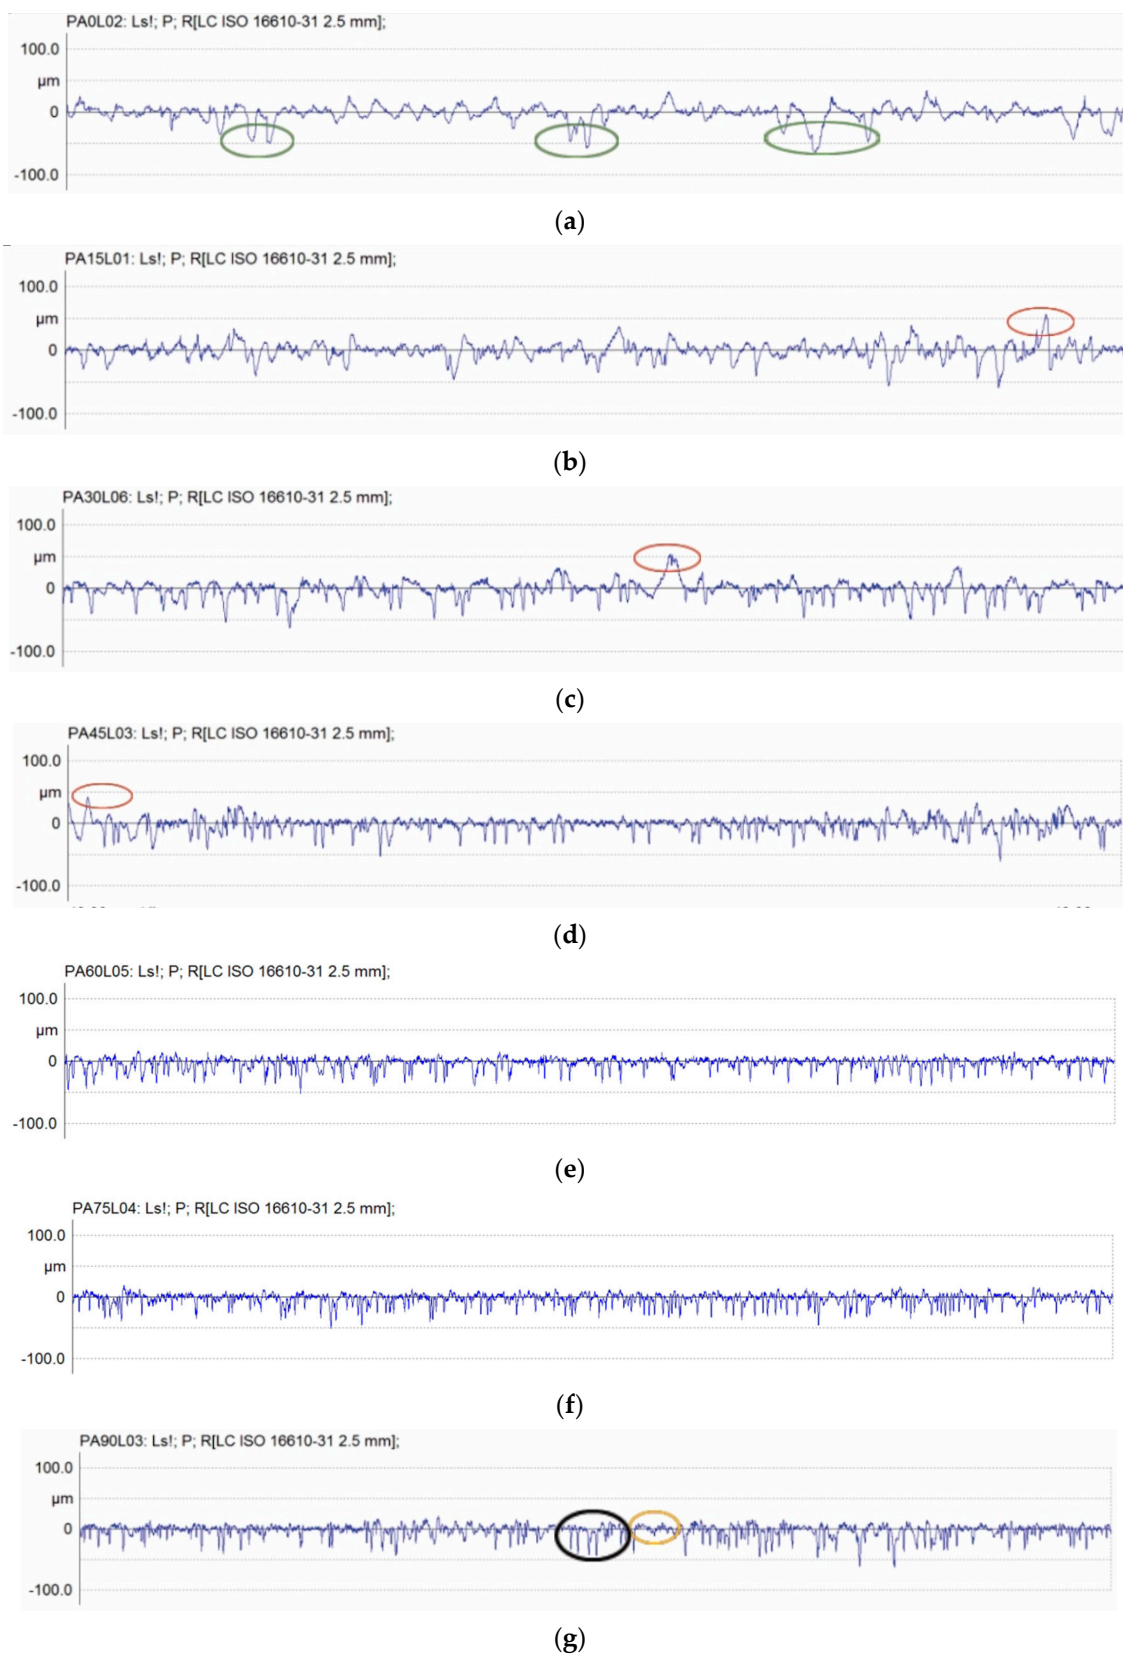
**Figure 12.** Comparison of roughness profiles from laser cut surfaces: (a) along the grain; (b) at 15° (fuzzy grain encircled with red); (c) at 30°; (d) at 45°; (e) at 60°; (f) at 75°; (g) at 90° as related to the grain. Highlights code: red—raised fiber; green—deep isolated valleys; black—earlywood; yellow—latewood.

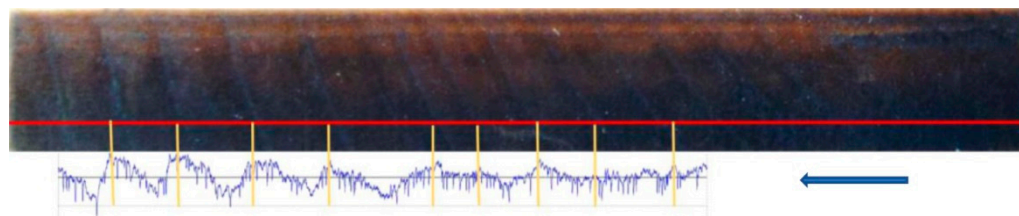
**Figure 13.** Anatomical waviness seen on a maple surface processed by laser at  $75^\circ$  as related to the grain and selected measured profile. The location of the selected profile is marked with the red line. With yellow, the border of the annual ring is marked. The arrow indicates the growth direction.

Waviness, evaluated by  $W_a$ , was higher for the laser cutting in comparison with CNC ( $u = 2 \text{ m/min}$ ), from 1.4 to almost 3 times, as can be observed in Figure 10. At least, for laser cutting, the waviness was visibly associated with a wood response after interaction with the laser. In Figure 13, a measured profile containing both, roughness and waviness, was extracted from a surface processed by laser under a  $75^\circ$ . The red line indicates the location on the surface of the selected profile.

Sudden gaps are seen in the measured profile, which corresponds to the earlywood, at the border of the annual ring. Lesser dense earlywood compared with latewood was processed deeper by the laser. The measured profiles appear like indentations, with the highest peaks in the latewood and valleys in the earlywood. The laser seems to have more pronouncedly carbonized earlywood; especially, at the annual ring limit creating gaps below the processed surface. A similar observation was made by other researchers [32] when examining spruce engraved by the laser, or on cut-through larch [1].

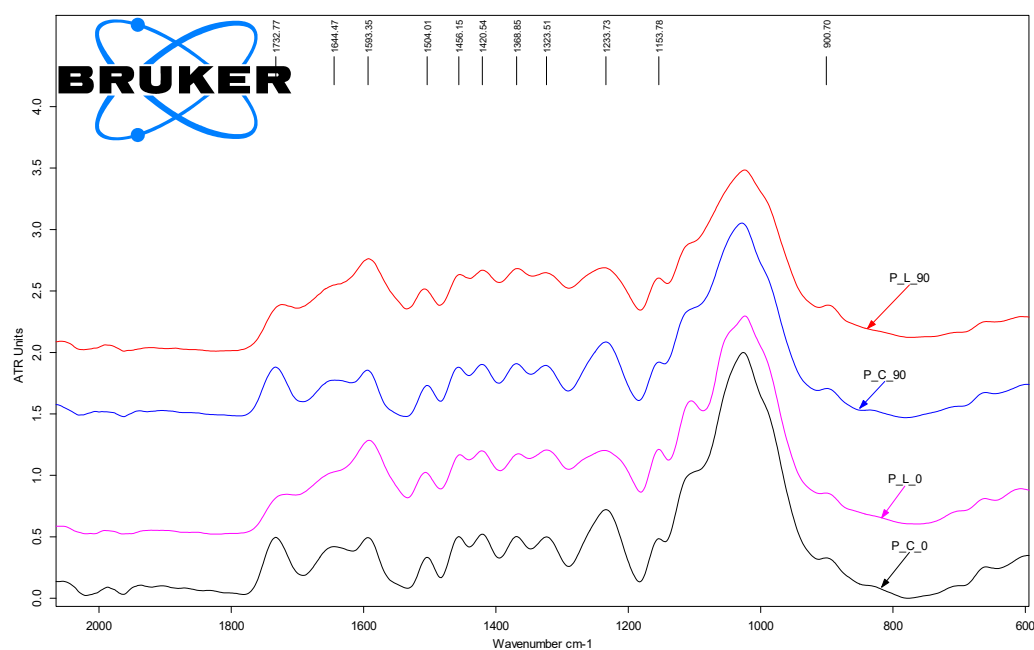
**Figure 14.** Comparative FTIR-ATR spectra in the fingerprint region ( $1800\text{--}600\text{ cm}^{-1}$ ) of control (P\_C\_0, P\_C\_90) and laser cut through (P\_L\_0, P\_L\_90) maple (*Acer pseudoplatanus*) wood surfaces at angles of  $0^\circ$  and  $90^\circ$  as related to the grain.

The FTIR spectra in the fingerprint region ( $1800\text{--}600 \text{ cm}^{-1}$ ) recorded for the laser-cut maple surfaces at two different angles ( $0^\circ$ ,  $90^\circ$  as related to the grain) are presented in Figure 14 in comparison with those corresponding to similar surfaces processed by CNC routing considered as controls.

The main absorption bands in the control spectra of maple wood and their assignment based on the literature are as follows:  $1733 \text{ cm}^{-1}$  (stretching of unconjugated carbonyl groups present as acetyl groups in hemicelluloses/pentosanes and  $\text{C=O}$  groups in lignin),  $1645 \text{ cm}^{-1}$  (vibration of conjugated carbonyl groups/aromatic ketones in the structure of lignin),  $1594 \text{ cm}^{-1}$  (aromatic skeletal breathing and  $\text{C=O}$  groups stretch in lignin),  $1504 \text{ cm}^{-1}$  (aromatic skeletal vibration in lignin),  $1456 \text{ cm}^{-1}$  (asymmetric deformation of aromatic C-H, asymmetric bending  $-\text{CH}_3$  in lignin),  $1421 \text{ cm}^{-1}$  (asymmetric C-H deformation in lignin and carbohydrates),  $1369 \text{ cm}^{-1}$  (symmetric C-H deformation in cellulose and hemicelluloses),  $1324 \text{ cm}^{-1}$  (C-O vibration in syringyl derivatives, syringyl ring breathing, C-O alkyl-aryl ether bond assigned to methoxyl groups in lignin),  $1234 \text{ cm}^{-1}$  (C-O stretch in lignin and xylan, syringyl ring),  $1154 \text{ cm}^{-1}$  (antisymmetric stretching of C-O-C ether bridge in cellulose and hemicelluloses),  $1026 \text{ cm}^{-1}$  (C-O stretching in cellulose/hemicelluloses and, alcoholic  $-\text{OH}$  groups) and  $900 \text{ cm}^{-1}$  (C-H deformation in cellulose ring) [33,34].

As a result of the thermal effect of laser processing, some obvious alterations of the wood surface chemistry were highlighted by FTIR regardless of the cutting angle. First of all, an important decrease in the distinct absorption band at  $1732\text{ cm}^{-1}$  (acetyl groups in hemicelluloses/pentosanes) occurs in parallel with a less important decrease in the absorption band at  $1369\text{ cm}^{-1}$  (holocellulose), while the small absorption at about  $900\text{ cm}^{-1}$  (assigned to cellulose) seemed only lightly affected, indicating deacetylation and further degradation of hemicelluloses, which are more sensitive to thermal degradation compared to cellulose. Another important change was the dramatic decrease up to almost total disappearance of the absorption at  $1645\text{ cm}^{-1}$  (conjugated carbonyl, aromatic ketones in the structure of lignin), occurring in parallel with an important increase in the absorption band at  $1594\text{ cm}^{-1}$ , characteristic of aromatic ring breathing, while the most characteristic absorption band of lignin at  $1504\text{ cm}^{-1}$  (aromatic skeletal vibration) seemed only little affected. All these reflect structural changes in lignin, such as condensation processes, which may involve the reactive conjugated carbonyl groups in the  $\alpha$  position of the propane side chain, as also suggested by [35]. They proposed a reaction pathway including oxidation of  $\alpha\text{-C=O}$  groups followed by decarboxylation and further condensation with adjacent benzene rings in acidic medium leading to diphenyl-methane structures. Furthermore, the slight decrease in the absorption at  $1324\text{ cm}^{-1}$ , visible for the laser-processed samples in Figure 14, may indicate cleavage of the C-O alkyl-aryl ether bond in the methoxyl groups, respectively, some demethoxylation of the syringyl units, which will favor further condensation of lignin due to more free reactive sites. The absorption at  $1234\text{ cm}^{-1}$ , which cumulates a contribution of the syringyl ring with C-O vibration in lignin and xylan acetyl groups, decreased as intensity but became wider, supporting the previously presented changes in the structure of hemicelluloses and lignin. Finally, the absorptions at  $1154\text{ cm}^{-1}$  (C-O-C ether bridges in the structure of polysaccharides) and  $1105\text{ cm}^{-1}$  present as shoulders on the wider absorption band with a maximum at  $1026\text{ cm}^{-1}$ , seem to become more evident after laser processing, indicating some changes in the structure of cellulose. These may include dehydration processes and cross-linking by new ether bridges, as suggested by [35].
